# Management of Extensive Carious Lesions in Permanent Molars of a Child with Nonmetallic Bonded Restorations — A Case Report

• Omar El-Mowafy, BDS, PhD, FADM •

© J Can Dent Assoc 2000; 66:302-7

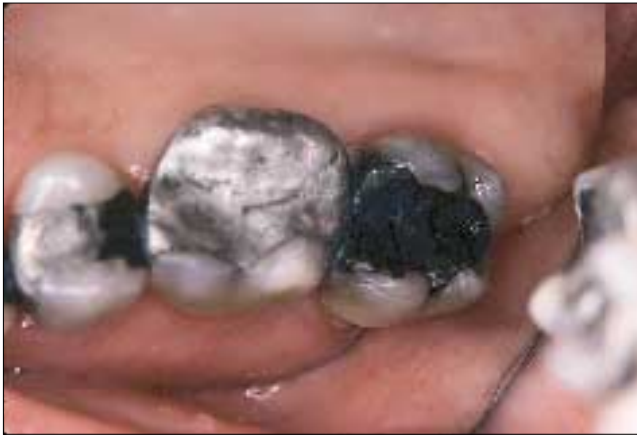
**Figure 1:** Judging by the extent of corrosion, amalgam restorations on maxillary second premolar and second molar teeth were probably fabricated from a conventional amalgam alloy. The one on the first molar shows much less corrosion, indicating that it could have been made from a high-copper amalgam alloy.

The demand for esthetic restorative materials for the replacement of decayed or damaged tissue in the posterior teeth has increased significantly. The growing controversy about amalgam's mercury content is one of the forces behind this trend: There is increasing environmental concern about the use of mercury in a number of industries, including the dental materials industry. Many manufacturers of dry batteries and manufacturers of house paints are now producing mercury-free products. Mercury in amalgam restorations is present in a reacted compound form that is much less toxic than the elemental form. In spite of this, mercury content remains an issue for health and environmental reasons. Another force behind the trend away from amalgam is that many people perceive these restorations as unsightly. Finally, excessive tarnish and corrosion are problems with conventional amalgam formulations; however, high-copper-content alloys tend to perform better in this respect (Fig. 1).

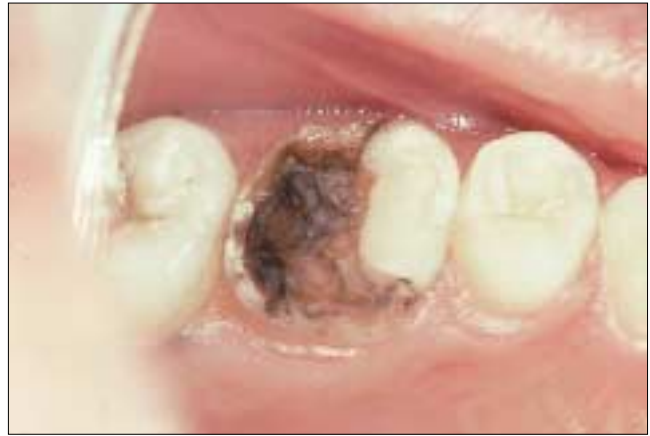
**Figure 2:** Left maxillary first molar of a 12-year-old girl with lost amalgam restoration and evidence of recurrent caries.

Clinical examination revealed a lost restoration and the presence of recurrent caries, which was the likely reason for the failure of the original amalgam restoration (Fig. 2). Treatment options included replacement of the lost amalgam restoration with a pin-retained amalgam build-up followed with a crown restoration; alternatively, a pin-retained cast gold onlay restora-

tion could be made. However, because of the young age of the patient, it was desirable to delay these elaborate and invasive types of treatment as much as possible until some recession of the pulp horns had taken place. Instead, a bonded resin composite onlay restoration was selected. This option required minimal tooth preparation and was the least invasive treatment.

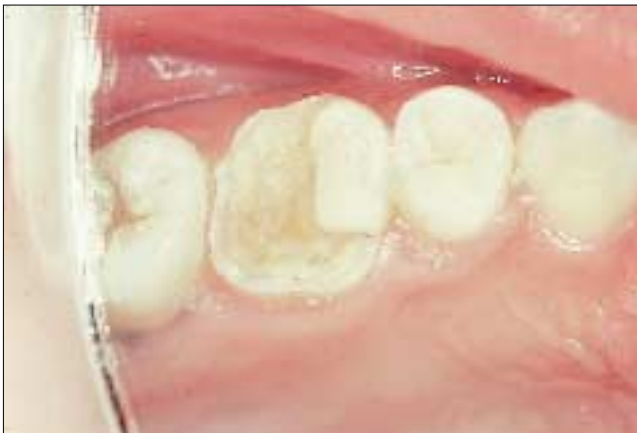
**Figure 3:** Cavity preparation for an adhesive resin composite onlay restoration.

After careful removal of the carious tooth tissue with a large round bur at slow speed with light intermittent pressure, cavity margins were finished with a butt-joint (Fig. 3). Shallow putt holes were made using a small round bur at slow speed at available sites at the corners of the preparation. These holes increased the surface area for adhesion through bonding to dentin and, more importantly, provided secondary means of resistance against horizontal displacement. After cavity preparation, an impression was taken using a silicone material (Express, 3M, St. Paul, Minn.). Jaw relation registration was then performed, and the cavity was temporarily restored with IRM (Dentsply, Milford, Del.). The impression was poured in dental stone and the cavity margins were marked in pencil. Herculite XRV Laboratory kit (Kerr Manufacturing Co., Romulus, Mich.) was used for fabrication of an indirect resin composite restoration. Die spacer was applied to the cavity surfaces except the marginal areas, and the cavity surfaces were sealed with the die sealer provided. A coat of separating medium was applied and allowed to dry. The onlay restoration was built incrementally using appropriate shades of dentin and enamel resin composite material in the kit. Each increment was light-cured before addition of the next one. At the marginal areas of the cavity preparation, when an increment of composite material was adapted against the margin, an imprint of the margin was made on the composite increment. When the onlay was removed from the model, it was easy to see where the cavity margins were; trimming of the added composite increment was made accordingly. To ensure optimum contact with the adjacent tooth, the contact area of the adjacent tooth was lightly scraped with a sharp knife to create space to build a positive contact area for the onlay. After occlusal adjustment, the fabricated onlay restoration was subjected to heat treatment through boiling in water for 10 minutes while seated on the model (Fig. 4). The fitted surface of the onlay was cleaned with a micro-etcher (Micro-etcher model-erc, Danville Engineering, San Ramon, Calif.) using 50  $\mu$ m aluminum oxide powder in a dust-limiting chamber

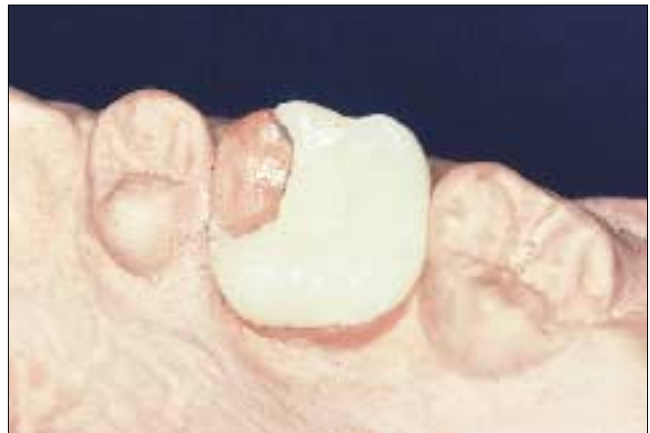
**Figure 4:** The dentist-fabricated onlay restoration seated on the stone model.

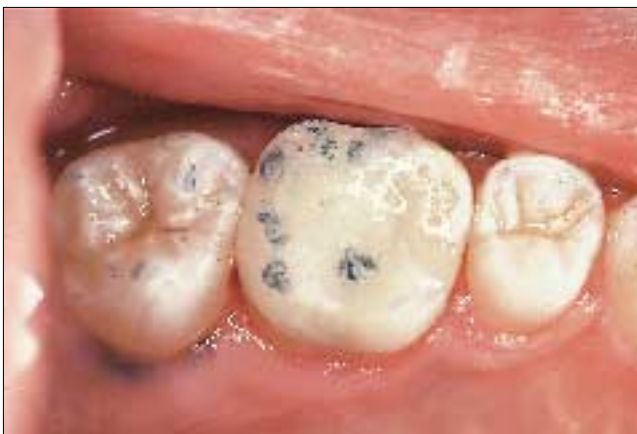
**Figure 5:** Occlusal adjustment was done after rubber dam removal.

At the next appointment, rubber dam was applied and the onlay was tried-in to verify seating. Both enamel and dentin were then etched with 37% phosphoric acid gel for 20 seconds (Ultra-Etch, Ultradent Products Inc., South Jordan, Utah), rinsed for 10 seconds and dried gently with a weak stream of air until water puddles disappeared from the line angles but the surfaces remained moist. Etched surfaces were then primed with Prime and Bond 2.1 (Dentsply DeTrey GmbH, Konstanz, Germany). One thin coat was applied thoroughly and light-cured for 20 seconds. A second layer was applied but was left uncured. A dual-cure resin cement (Enforce, Dentsply Caulk, Milford, Del.) was mixed and applied onto the fitted surface of the onlay. The onlay was then seated in place and maintained under pressure. Most excess cement was removed with a dry primer brush. Initial light-curing for only five seconds followed, and the rest of excess cement material was removed with an explorer. The restoration was then subjected to full light-curing from all accessible aspects. The rubber dam was removed and occlusal adjustment carried out (Fig. 5). The onlay was polished with Soflex discs (3M dental products, St. Paul, Minn.).

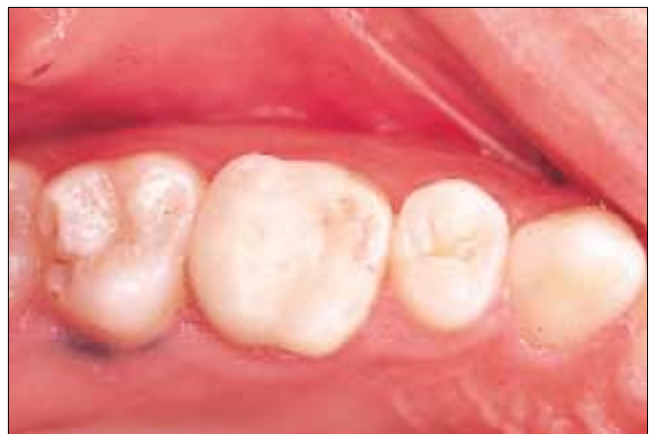
**Figure 6:** View of the cemented onlay restoration two years after placement.

**Figure 6** is a picture of the onlay restoration two years after

placement. While the occlusal anatomy of the onlay restoration was not detailed, the function of the tooth was restored with this procedure. Today, after two years, the gingival margin of the restoration is now 1 mm to 1.5 mm above the level of the gingiva. This is due to continued eruption and repositioning of the tooth as changes in occlusion took place with the growth of the bony structures of the jaw typical for this age. Tooth vitality was maintained throughout and a more extensive restoration was avoided, outcomes that are in the best interest of a patient who is only 12 years old.

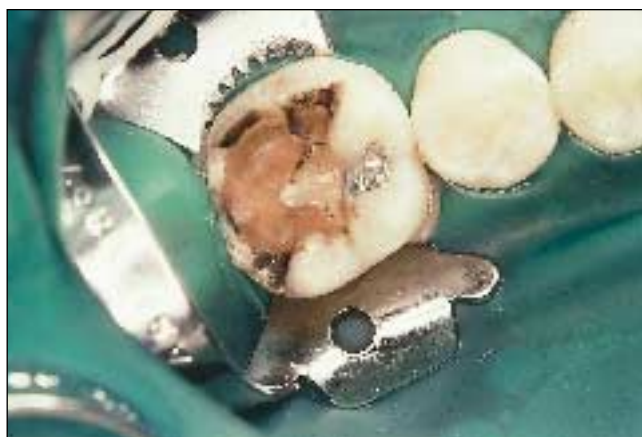
**Figure 7:** This massive carious lesion on lower first molar tooth occurred underneath an existing amalgam restoration.

In the next case the child presented with a fractured amalgam restoration with extensive recurrent caries that had destroyed the distal and most of the facial aspects of the crown of the tooth (Fig. 7). Pulp testing confirmed vitality of the tooth. Cavity preparation followed. First, the periphery of the carious lesion was negotiated to expose sound tooth tissue at the margins. The soft central carious lesion was then removed with great care with a large round bur at slow speed using light, intermittent pressure. A thin layer of calcium hydroxide was applied to the deepest central area of the cavity and the cavity was restored with IRM. Three months after the pulp-capping procedure, pulp vitality was tested

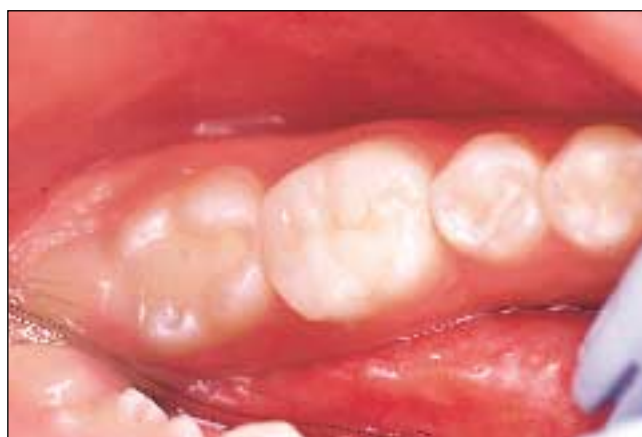
**Figure 9:** View of the cemented IPS Impress onlay restoration nine months after placement.

The restoration was later tried-in and then cemented following the same procedure and materials as above. Figure 9 shows a picture of this onlay restoration nine months after cementation.

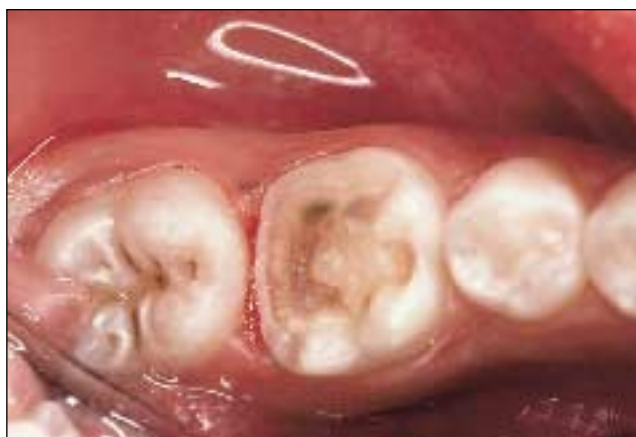
**Figure 8:** After three months of pulp-capping, the tooth was prepared to receive an onlay ceramic restoration.

once more and the IRM restoration was removed. Final preparation of the cavity to receive an onlay restoration was completed (Fig. 8). An impression was taken in a silicone material (Express, 3M Dental Products, St. Paul, Minn.), and a pressed ceramic onlay restoration (IPS Impress, Ivoclar North America, Amherst, NY.) was fabricated in a dental laboratory. The fitted surface of the ceramic restoration was microetched with aluminum oxide powder to provide the microroughness necessary for bonding with the resin cement.

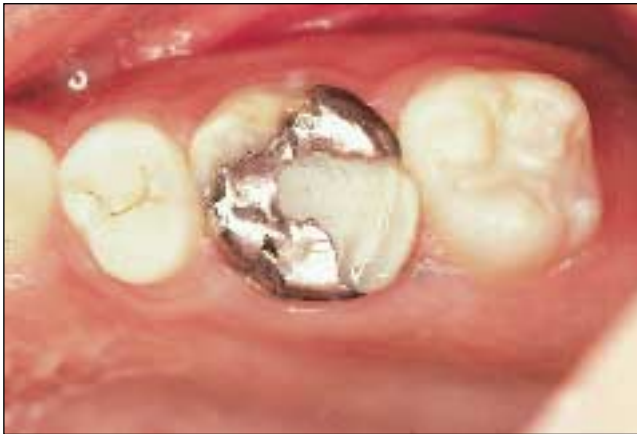
**Figure 10:** This maxillary first molar presented with a combined amalgam/resin composite restoration with evidence of breakdown.

This tooth presented with a combination of an amalgam restoration and a resin composite restoration with evidence of failure (Fig. 10). The resin composite part was a repair undertaken when the child was going through a course of orthodontic treatment and a recurrent carious lesion was detected while the tooth had an orthodontic band around it. On removal of the amalgam restoration, more recurrent caries was found underneath it. Cavity preparation continued, and the tooth was prepared to receive a direct resin composite restoration. Wide horizontal retention grooves were prepared at available sites at the corners of the cavity to aid in the stability and retention of the restoration (Fig. 11). The cavity was etched for 20 seconds with an acid etchant and, after rinsing and drying as mentioned above, a primer/bonding resin was applied (Prime and Bond NT, Dentsply DeTrey GmbH, Konstanz, Germany). The cavity was restored incrementally with a resin composite material (Herculite XRV, Kerr Manufacturing Co., Romulus, Mich.). Figure 12 is a picture of the restoration at eight months.

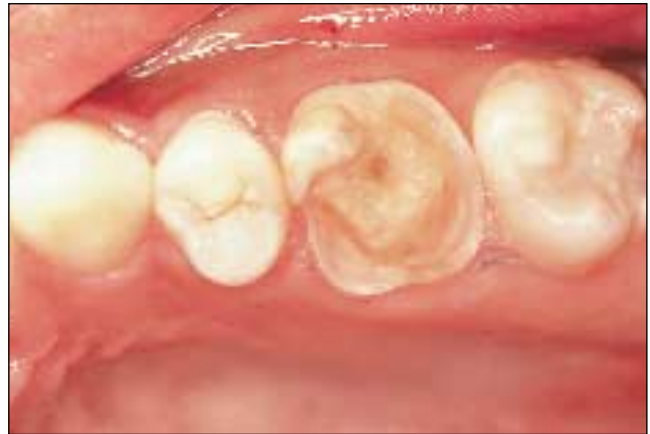
**Figure 11:** Completed cavity preparation for an adhesive resin composite restoration.

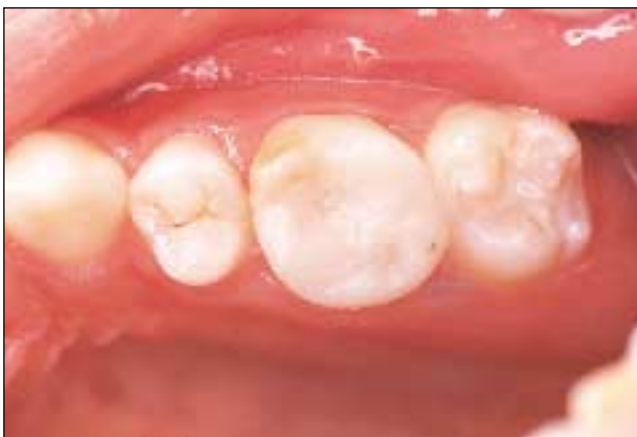
**Figure 12:** Completed direct resin composite restoration eight months after placement.

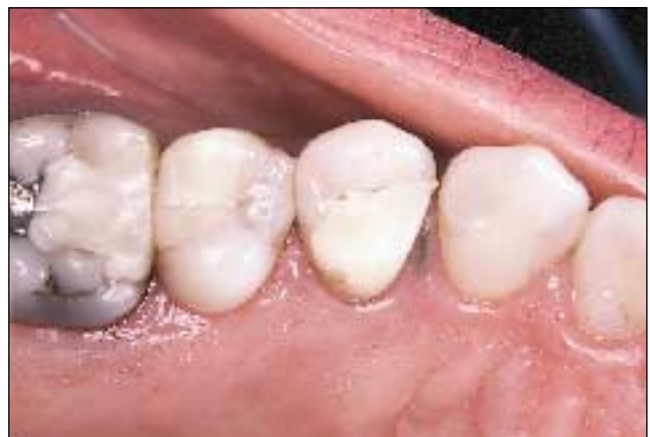
**Figure 13:** Large resin composite restorations on maxillary premolars eight years after placement. These were made using the material P-50 (3M).
