Complications of Mandibular Molar Replacement with a Single Implant: A Case Report

Case Report

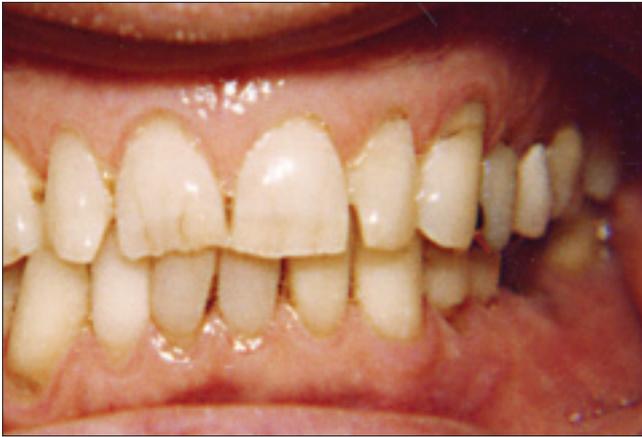
Figure 1a: Preoperative frontal view showing missing crown on tooth 36.

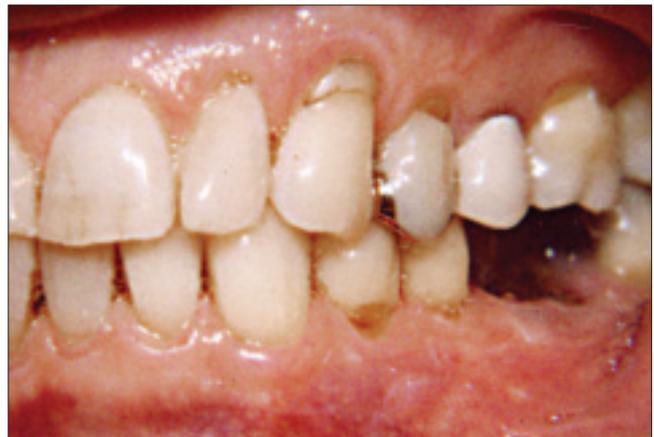
A 57-year-old man in excellent health, with no known allergies or sensitivities to medications, presented to Prosthodontics Intermedica (Fort Washington, Pa.) with the chief complaint “my crown and post came off” (Figs. 1a and 1b). He desired an estimate for an implant. In general, the patient sought dental care only when dental emergencies occurred.

Figure 1b: Preoperative left view of tooth 36.

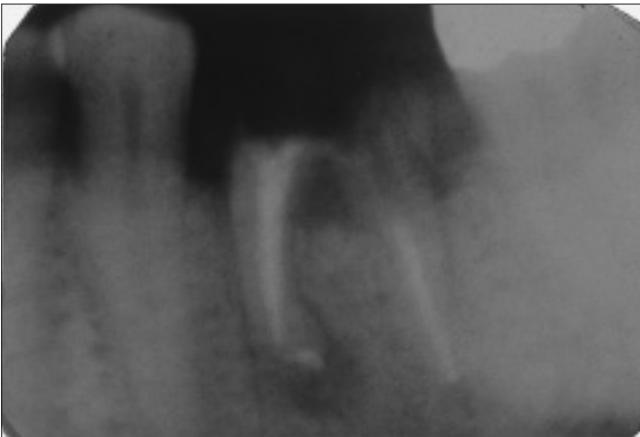
Initial clinical evaluation revealed parafunctional habits. Abfraction lesions were present on teeth 13, 14, 15, 24, 25, 34, 35 and 43, and incisor wear patterns were consistent with parafunction. The patient's general periodontal condition was healthy, despite the fact that he did not seek regular professional oral hygiene. Tooth 36 had a history of endodontic therapy. Its crown was absent, there was extensive decay in the pulp chamber and a periapical radiolucency appeared at the apex of the mesial root. The tooth was determined to be nonrestorable (Fig. 2).

Figure 2: Preoperative periapical radiograph of tooth 36.

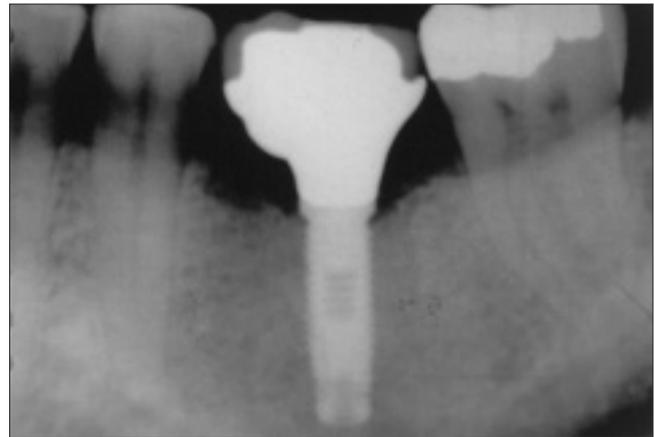
Figure 3: Radiograph of single-implant ceramic crown retained with a metal screw.

The patient was interested in the implant option; however, for financial reasons, he sought a second opinion regarding a “cheaper solution.” Within a year of his initial visit, another treating dentist had extracted tooth 36 and had restored it with a single standard-diameter implant supporting a screw-retained ceramo-metal crown (Fig. 3).

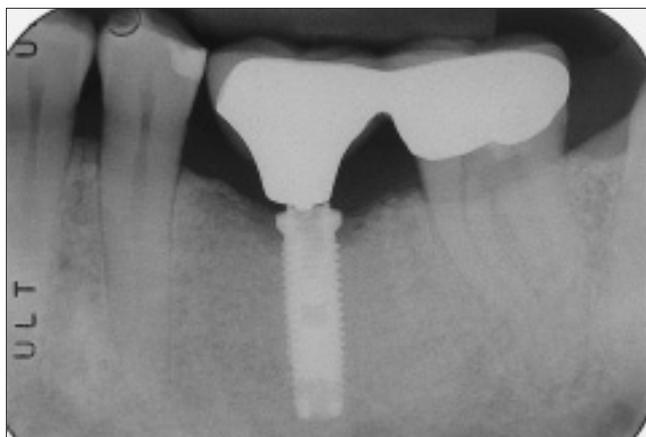
Fifteen months after the patient’s first return visit, he presented to the clinic wearing a 2-unit ceramo-metal fixed partial denture supported by tooth 37 and an implant in the area of tooth 36 (Fig. 4). The retainer of the fixed partial denture was not seated on the implant replacing tooth 36, but was cantilevered off tooth 37. The abutment screw had fractured. The patient was advised of the risk of complications that might arise from such a prosthetic design, including damage to the implant and fracture of the solder joint. Approximately 2 months later, the patient returned with the complaint of a fractured restoration. Further evaluation revealed that the solder joint between tooth 37 and the implant at tooth 36 had fractured (Fig. 5a).

Figure 4: Periapical radiograph of splinted tissue-integrated prosthesis to tooth 37 with a ceramo-metal retainer.

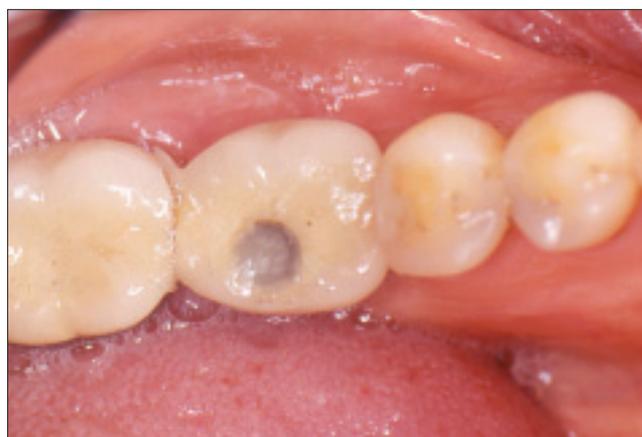
Figure 5a: Occlusal view of solder joint fracture between tissue-integrated prosthesis and tooth 37.

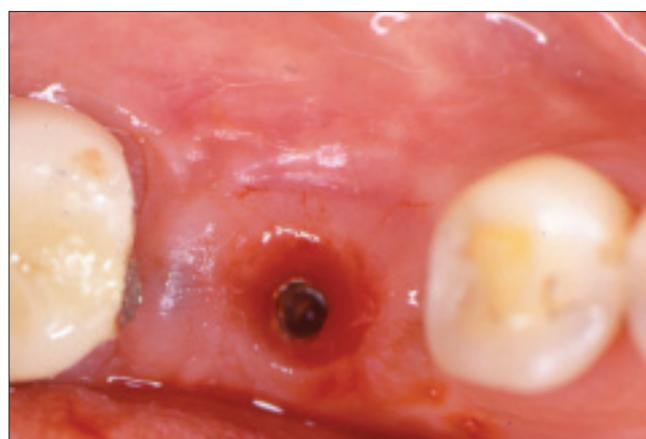
The abutment screw had fractured because of the biomechanical overload on the prosthesis. After removal of the fractured abutment screw (Fig. 5b), it was observed that the internal threads of the Brånemark System implant were damaged. In addition, the hexagonal portion of the implant was damaged due to friction caused by the ill-fitting splinted

Figure 5b: Solder joint fracture between tooth 37 and implant at 36 with soft tissue irritation.

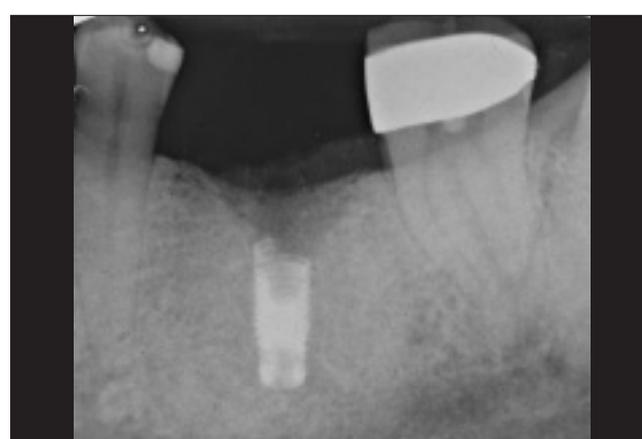
Figure 6: Fractured abutment screw in implant at site 36 with hexagonal portion of implant damaged.

prosthesis (Fig. 6). Thus, it would not be possible to use the existing implant for the final restoration.

Recommendation was made for the placement of 2 new implants to support a ceramo-metal screw-retained restoration replacing the mandibular left first molar, bypassing the previously placed implant. Consideration was given to trephining out the existing implant; however, significant bone loss and bone damage from heat generation along with parasthesia were of major concern in this patient. Instead, the implant, which was not fractured, was shortened, using copious amounts of saline irrigation, to create more room for the mesial and distal implants while preserving the bone. This was the least invasive form of treatment for this failed implant. Informed consent was obtained from the patient after all options for retreatment were explained.

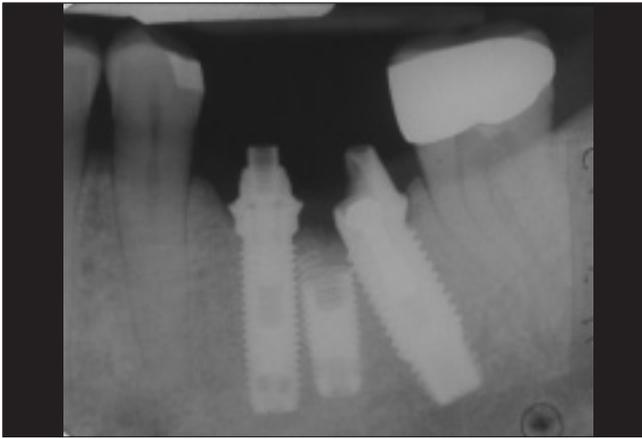
Figure 7: A periapical radiograph was taken at time of delivery to verify the abutments.

Eight months after the initial surgery, the abutments were connected. A 3-mm 17-degree angulated abutment was used for the distal fixture, and a 1-mm Estheticone abutment (Nobel Biocare, USA, Inc.) was used for the mesial fixture. Radiographic verification of the newly fitted abutments was obtained (Fig. 7). Screw-retained impression copings were modified for the impression procedure and, for the fabrication of a conversion prosthesis, a fixed provisional acrylic restoration was made.⁷ The fixed provisional acrylic restoration would provide for loading during stage II of surgery, and was used as an interim restoration until the final restoration was fabricated.

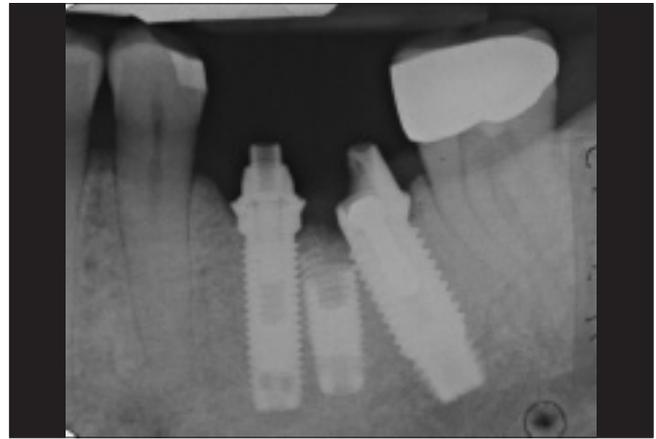
Figure 8: Periapical radiograph of tissue-integrated prosthesis taken at time of delivery.

Laboratory procedures included the fabrication of the crown, which was made of a porcelain fused to high-gold-content alloy. The 2-implant porcelain-gold restoration was retained by 2 gold prosthetic screws, which were torqued to 10 Ncm to prevent loosening. Delivery of the final restoration included confirmation that proximal contact allowed the patient to perform normal oral hygiene procedures using dental floss between the teeth. The buccal and lingual contours of the 2-implant-supported molar restoration and the recontouring of the left second molar restored not only the arch alignment, but also the occlusal plane, function and esthetics. The occlusal scheme for all molars was evaluated to ensure a firm centric contact with no contact in lateral excursions. A postoperative periapical radiograph (Fig. 8) confirmed the seating of the 2-implant-supported molar restoration at the time of delivery. Oral hygiene instructions were reinforced and the importance of periodic recall visits was emphasized.

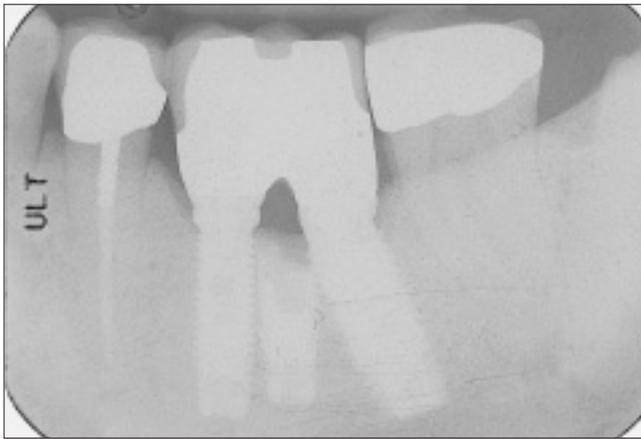
Figure 9: Periapical radiograph at 6.5-year follow-up. There is bone regeneration between the 2 functioning implants and above the sectioned implant.

For the past 6.5 years, the patient has been monitored at recall visits and has been doing well with the prosthesis. Radiographic evaluation has indicated a stable periodontal

condition with little or no bone loss associated with the osseointegrated implants (Fig. 9).
