# Management of Extensive Carious Lesions in Permanent Molars of a Child with Nonmetallic Bonded Restorations — A Case Report

*The badly decayed molar teeth of a 12-year-old were restored using resin composite and ceramic restorations. The maxillary first left permanent molar, which had an extensive carious lesion that had destroyed most of the coronal hard tissues of the tooth, was restored to shape and function with a heat-treated resin composite onlay restoration. The restoration was followed up for two years. The mandibular right first molar had a failing large amalgam restoration with extensive recurrent caries. After a three-month period of pulp-capping, the tooth was restored with a bonded ceramic onlay restoration. A nine-month follow-up of this restoration is provided. The maxillary right first molar, which also had a failing large amalgam/resin composite restoration, was restored with a direct resin composite restoration. Under traditional treatment regimens, these extensive cavities would have been treated using more invasive procedures such as pin-retained restorations or elective root canal therapy, post placement, core build-up and crowning. Bonded non-metallic resto

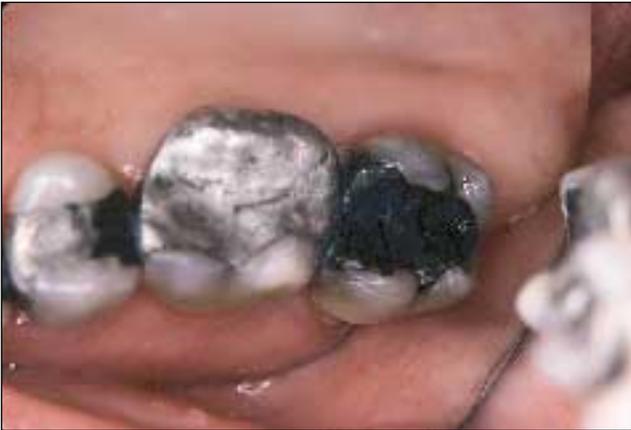
**Figure 1:** Judging by the extent of corrosion, amalgam restorations on maxillary second premolar and second molar teeth were probably fabricated from a conventional amalgam alloy. The one on the first molar shows much less corrosion, indicating that it could have been made from a high-copper amalgam alloy.

The demand for esthetic restorative materials for the replacement of decayed or damaged tissue in the posterior teeth has increased significantly. The growing controversy about amalgam's mercury content is one of the forces behind this trend: There is increasing environmental concern about the use of mercury in a number of industries, including the dental materials industry. Many manufacturers of dry batteries and manufacturers of house paints are now producing mercury-free products. Mercury in amalgam restorations is present in a reacted compound form that is much less toxic than the elemental form. In spite of this, mercury content remains an issue for health and environmental reasons. Another force behind the trend away from amalgam is that many people perceive these restorations as unsightly. Finally, excessive tarnish and corrosion are problems with conventional amalgam formulations; however, high-copper-content alloys tend to perform better in this respect (Fig. 1).

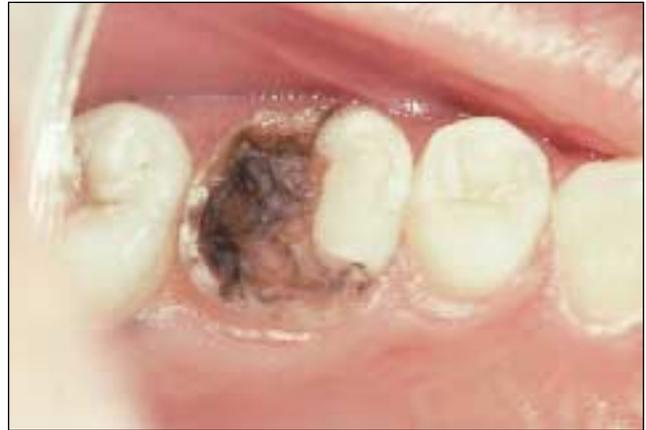
**Figure 2:** Left maxillary first molar of a 12-year-old girl with lost amalgam restoration and evidence of recurrent caries.

Clinical examination revealed a lost restoration and the presence of recurrent caries, which was the likely reason for the failure of the original amalgam restoration (Fig. 2). Treatment options included replacement of the lost amalgam restoration with a pin-retained amalgam build-up followed with a crown restoration; alternatively, a pin-retained cast gold onlay restoration could be made. However, because of the young age of the patient, it was desirable to delay these elaborate and invasive types of treatment as much as possible until some recession of the pulp horns had taken place. Instead, a bonded resin composite onlay restoration was selected. This option required

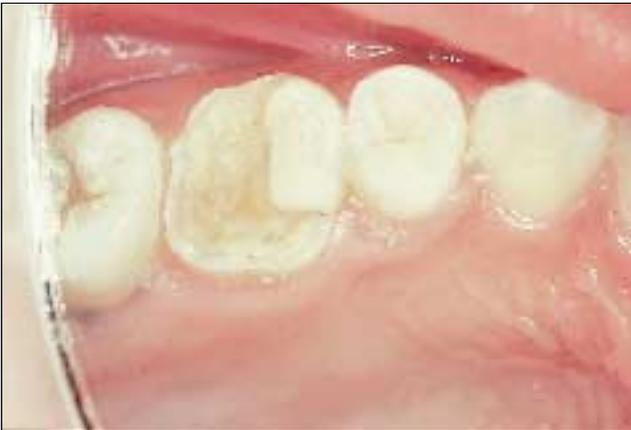
**Figure 3:** Cavity preparation for an adhesive resin composite onlay restoration.

After careful removal of the carious tooth tissue with a large round bur at slow speed with light intermittent pressure, cavity margins were finished with a butt-joint (Fig. 3). Shallow putt holes were made using a small round bur at slow speed at available sites at the corners of the preparation. These holes increased the surface area for adhesion through bonding to dentin and, more importantly, provided secondary means of resistance against horizontal displacement. After cavity preparation, an impression was taken using a silicone material (Express, 3M, St. Paul, Minn.). Jaw relation registration was then performed, and the cavity was temporarily restored with IRM (Dentsply, Milford, Del.). The impression was poured in dental stone and the cavity margins were marked in pencil. Herculite XRV Laboratory kit (Kerr Manufacturing Co., Romulus, Mich.) was used for fabrication of an indirect resin composite restoration. Die spacer was applied to the cavity surfaces except the marginal areas, and the cavity surfaces were sealed with the die sealer provided. A coat of separating medium was applied and allowed to dry. The onlay restoration was built incrementally using appropriate shades of dentin and enamel resin composite material in the kit. Each increment was light-cured before addition of the next one. At the marginal areas of the cavity preparation, when an increment of composite material was adapted against the margin, an imprint of the margin was made on the composite increment. When the onlay was removed from the model, it was easy to see where the cavity margins were; trimming of the added composite increment was made accordingly. To ensure optimum contact with the adjacent tooth, the contact area of the adjacent tooth was lightly scraped with a sharp knife to create space to build a positive contact area for the onlay. After occlusal adjustment, the fabricated onlay restoration was subjected to heat treatment through boiling in water for 10 minutes while seated on the model (Fig. 4). The fitted surface of the onlay was cleaned with a micro-etcher (Micro-etcher model-erc, Danville Engineering, San Ramon, Calif.) using 50  $\mu\text{m}$  aluminum oxide powder in a dust-limiting chamber (Microcab, Danville Engineering, San Ramon, Calif.). This

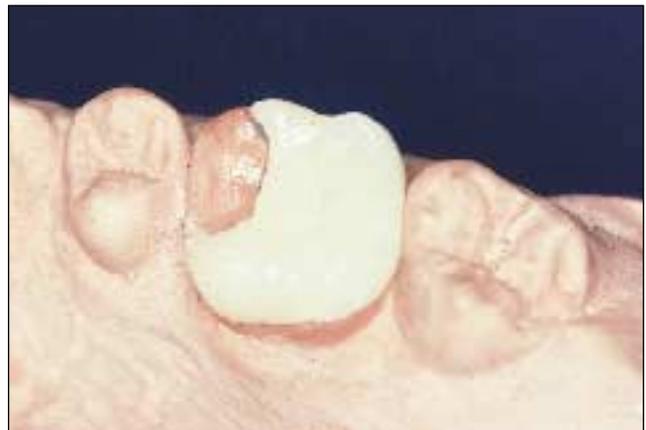
**Figure 4:** The dentist-fabricated onlay restoration seated on the stone model.

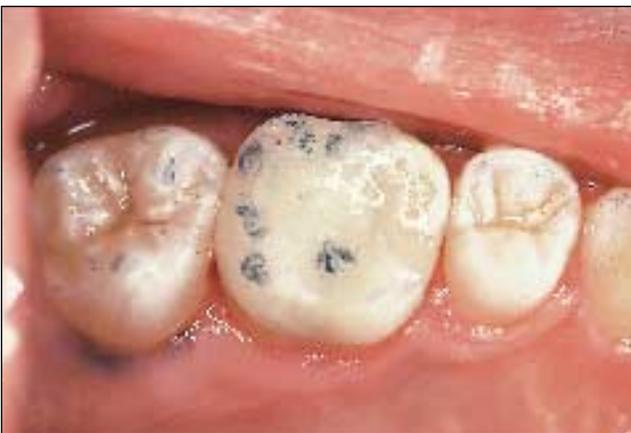
**Figure 5:** Occlusal adjustment was done after rubber dam removal.

At the next appointment, rubber dam was applied and the onlay was tried-in to verify seating. Both enamel and dentin were then etched with 37% phosphoric acid gel for 20 seconds (Ultra-Etch, Ultradent Products Inc., South Jordan, Utah), rinsed for 10 seconds and dried gently with a weak stream of air until water puddles disappeared from the line angles but the surfaces remained moist. Etched surfaces were then primed with Prime and Bond 2.1 (Dentsply DeTrey GmbH, Konstanz, Germany). One thin coat was applied thoroughly and light-cured for 20 seconds. A second layer was applied but was left uncured. A dual-cure resin cement (Enforce, Dentsply Caulk, Milford, Del.) was mixed and applied onto the fitted surface of the onlay. The onlay was then seated in place and maintained under pressure. Most excess cement was removed with a dry primer brush. Initial light-curing for only five seconds followed, and the rest of excess cement material was removed with an explorer. The restoration was then subjected to full light-curing from all accessible aspects. The rubber dam was removed and occlusal adjustment carried out (Fig. 5). The onlay was polished with Soflex discs (3M dental products, St. Paul, Minn.).

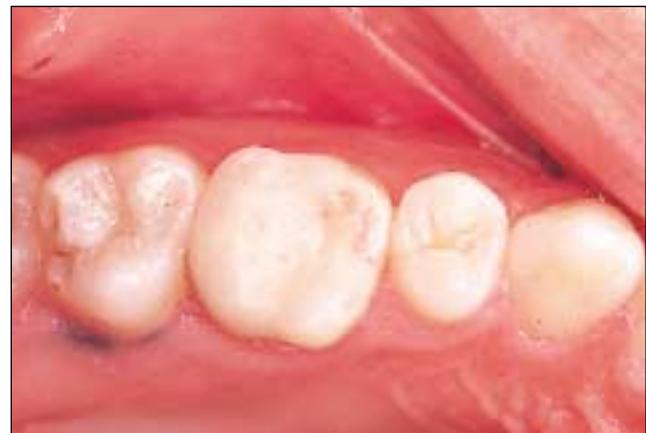
**Figure 6:** View of the cemented onlay restoration two years after placement.

**Figure 6** is a picture of the onlay restoration two years after placement. While the occlusal anatomy of the onlay restoration was not detailed, the function of the tooth was restored with this procedure. Today, after two years, the gingival margin of the restoration is now 1 mm to 1.5 mm above the level of the gingiva. This is due to continued eruption and repositioning of the tooth as changes in occlusion took place with the growth of the bony structures of the jaw typical for this age. Tooth vitality was maintained throughout and a more extensive restoration was avoided, outcomes that are in the best interest of a patient who is only 12 years old.

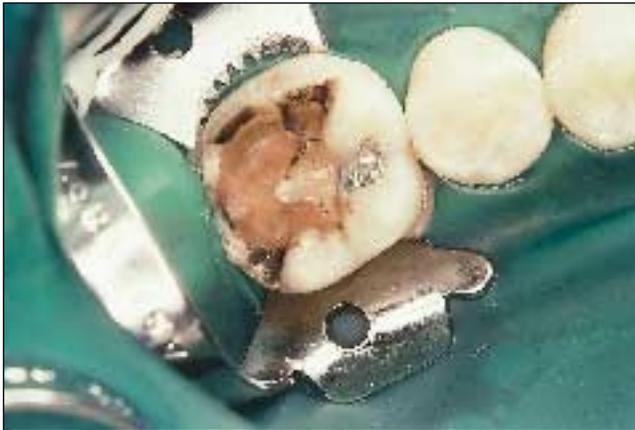
**Figure 7:** This massive carious lesion on lower first molar tooth occurred underneath an existing amalgam restoration.

In the next case the child presented with a fractured amalgam restoration with extensive recurrent caries that had destroyed the distal and most of the facial aspects of the crown of the tooth (Fig. 7). Pulp testing confirmed vitality of the tooth. Cavity preparation followed. First, the periphery of the carious lesion was negotiated to expose sound tooth tissue at the margins. The soft central carious lesion was then removed with great care with a large round bur at slow speed using light, intermittent pressure. A thin layer of calcium hydroxide was applied to the deepest central area of the cavity and the cavity

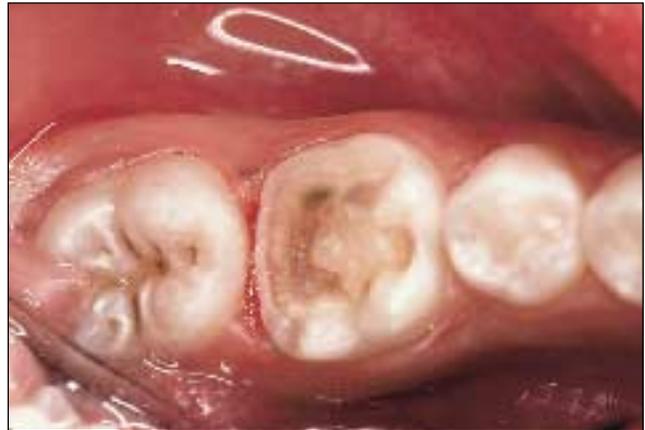
**Figure 8:** After three months of pulp-capping, the tooth was prepared to receive an onlay ceramic restoration.

was restored with IRM. Three months after the pulp-capping procedure, pulp vitality was tested once more and the IRM restoration was removed. Final preparation of the cavity to receive an onlay restoration was completed (Fig. 8). An impression was taken in a silicone material (Express, 3M Dental Products, St. Paul, Minn.), and a pressed ceramic onlay restoration (IPS Impress, Ivoclar North America, Amherst, NY.) was fabricated in a dental laboratory. The fitted surface of the ceramic restoration was microetched with aluminum oxide powder to provide the microroughness necessary for bonding with the resin cement.

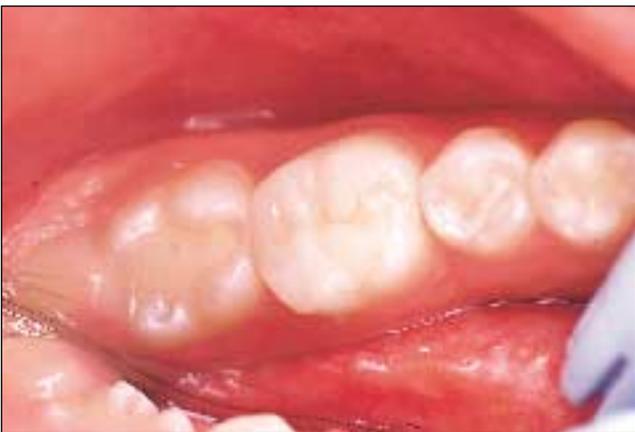
**Figure 9:** View of the cemented IPS Impress onlay restoration nine months after placement.

The restoration was later tried-in and then cemented following the same procedure and materials as above. Figure 9 shows a picture of this onlay restoration nine months after cementation.

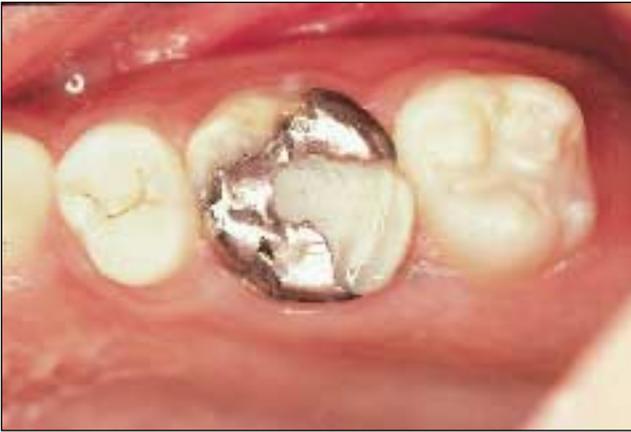
**Figure 10:** This maxillary first molar presented with a combined amalgam/resin composite restoration with evidence of breakdown.

This tooth presented with a combination of an amalgam restoration and a resin composite restoration with evidence of failure (Fig. 10). The resin composite part was a repair undertaken when the child was going through a course of orthodontic treatment and a recurrent carious lesion was detected while the tooth had an orthodontic band around it. On removal of the amalgam restoration, more recurrent caries was found underneath it. Cavity preparation continued, and the tooth was prepared to receive a direct resin composite restoration. Wide horizontal retention grooves were prepared at available sites at the corners of the cavity to aid in the stability and retention of the restoration (Fig. 11). The cavity was etched for 20 seconds with an acid etchant and, after rinsing and drying as mentioned above, a primer/bonding resin was applied (Prime and Bond NT, Dentsply DeTrey GmbH, Konstanz, Germany). The cavity was restored incrementally with a resin composite material (Herculite XRV, Kerr Manufacturing Co., Romulus, Mich.). Figure 12 is a picture of the restoration at eight months.

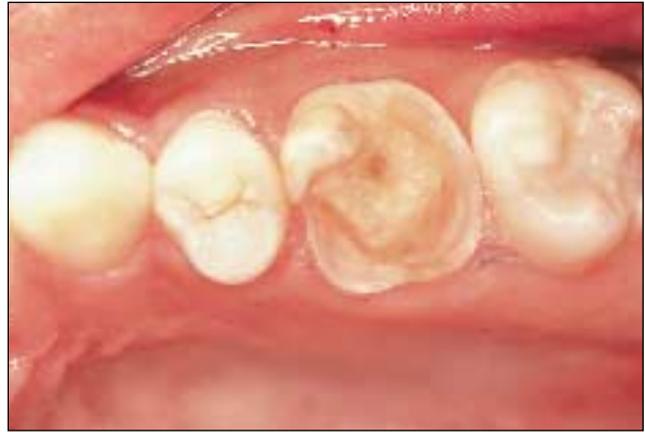
**Figure 11:** Completed cavity preparation for an adhesive resin composite restoration.

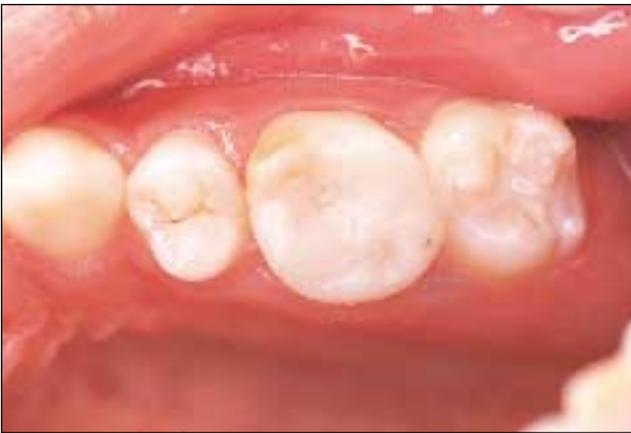
**Figure 12:** Completed direct resin composite restoration eight months after placement.

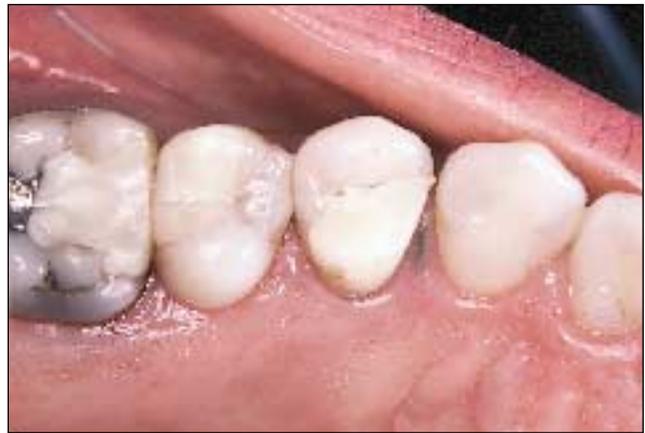
**Figure 13:** Large resin composite restorations on maxillary premolars eight years after placement. These were made using the material P-50 (3M).

Short-term data on the clinical performance of moderate-sized resin composite inlays are available.<sup>2</sup> Furthermore, since this study was published, improvements in the composite material and in the bonding procedure have been made. Therefore, inlays made from the current generation of materials would be expected to outperform inlays made from older materials. Occlusal wear should not be a concern, as resin composite materials that were available in the 1980s have been reported to be sufficiently wear-resistant.<sup>3</sup> Improved formulations of these materials that were available in the 1990s proved to perform even better in this respect.<sup>4</sup> Although bulk fracture of large resin composite restorations might be a concern, only long-term clinical trial studies can provide us with data about it. The author's own experience with these restorations has been positive. Figure 13 shows two large resin composite restorations on maxillary first and second premolar teeth eight years after placement. The one on the first premolar was placed as a build-up on a prefabricated post after root canal

therapy of the tooth in preparation for a crown restoration, which the patient was never able to afford. The restoration on the second premolar was placed as a final restoration on vital tooth tissues as partial replacement for the damaged buccal cusp.
