Complications of Mandibular Molar Replacement with a Single Implant: A Case Report

This case report describes prosthodontic complications resulting from the surgical placement of a single implant and treatment following these complications. Both the surgical and prosthodontic procedures are described for the treatment of a 57-year-old man who had previously received a single implant for the replacement of a missing molar. Using 2 implants, 1 mesial and 1 distal to the previously placed single implant proved reliable. A logical treatment solution is to use 2 implants for the replacement of a single molar to avoid prosthodontic complications.

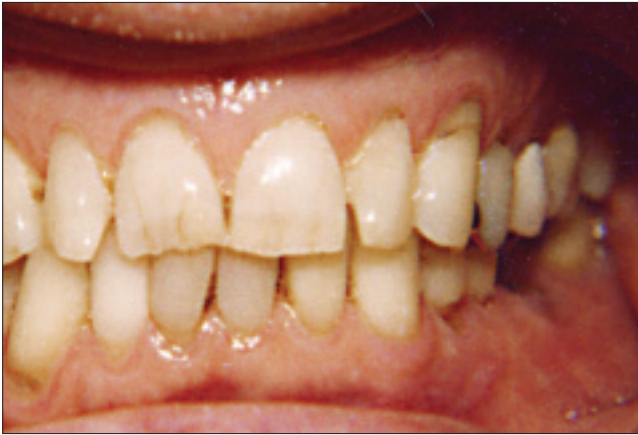
Figure 1a: Preoperative frontal view showing missing crown on tooth 36.

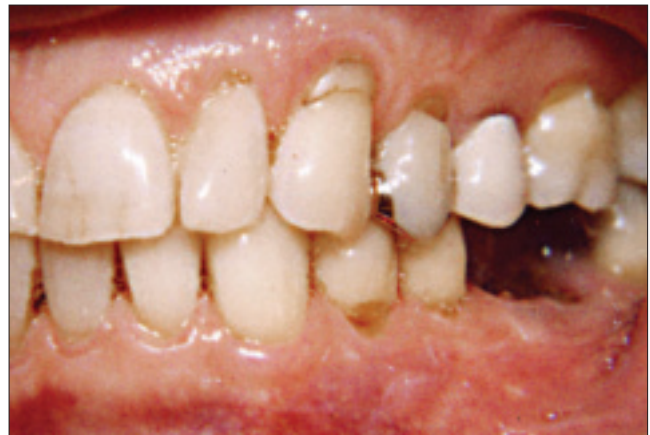
Figure 1b: Preoperative left view of tooth 36.

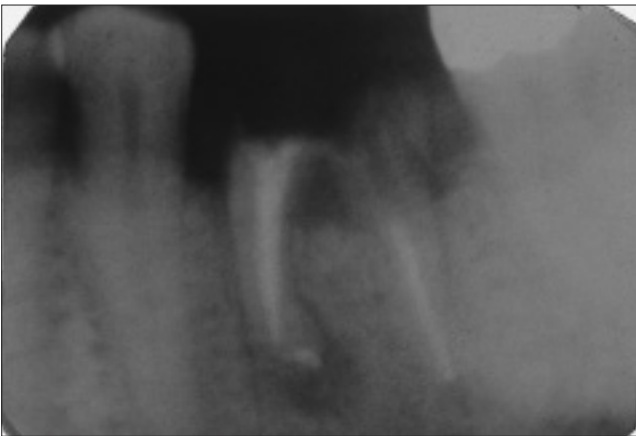
Initial clinical evaluation revealed parafunctional habits. Abfraction lesions were present on teeth 13, 14, 15, 24, 25, 34, 35 and 43, and incisor wear patterns were consistent with parafunction. The patient’s general periodontal condition was healthy, despite the fact that he did not seek regular professional oral hygiene. Tooth 36 had a history of endodontic therapy. Its crown was absent, there was extensive decay in the pulp chamber and a periapical radiolucency appeared at the apex of the mesial root. The tooth was determined to be nonrestorable (Fig. 2).

Figure 2: Preoperative periapical radiograph of tooth 36.

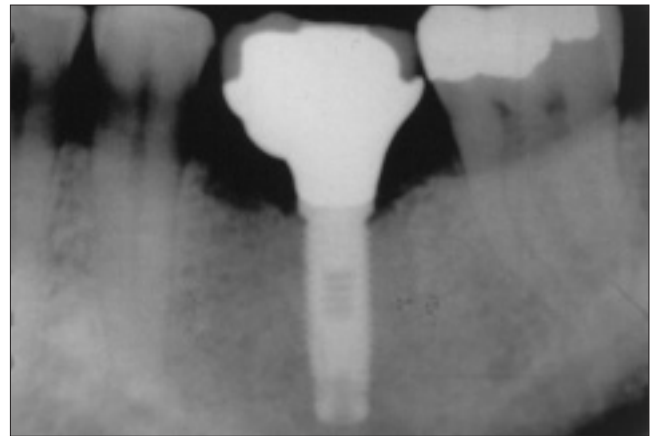
Figure 3: Radiograph of single-implant ceramic crown retained with a metal screw.

The patient was interested in the implant option; however, for financial reasons, he sought a second opinion regarding a “cheaper solution.” Within a year of his initial visit, another treating dentist had extracted tooth 36 and had restored it with a single standard-diameter implant supporting a screw-retained ceramo-metal crown (**Fig. 3**).

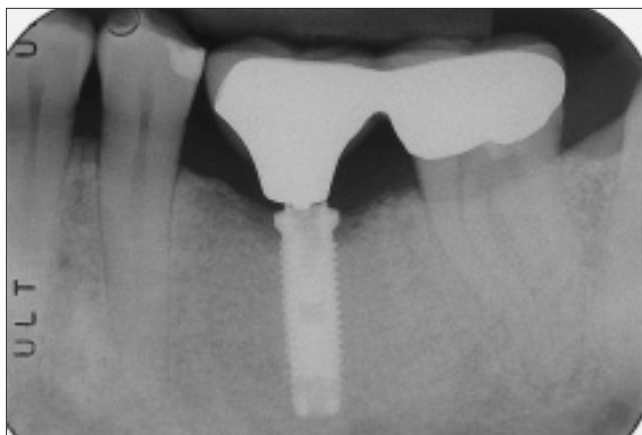
Fifteen months after the patient’s first return visit, he presented to the clinic wearing a 2-unit ceramo-metal fixed partial denture supported by tooth 37 and an implant in the area of tooth 36 (**Fig. 4**). The retainer of the fixed partial denture was not seated on the implant replacing tooth 36, but was cantilevered off tooth 37. The abutment

Figure 4: Periapical radiograph of splinted tissue-integrated prosthesis to tooth 37 with a ceramo-metal retainer.

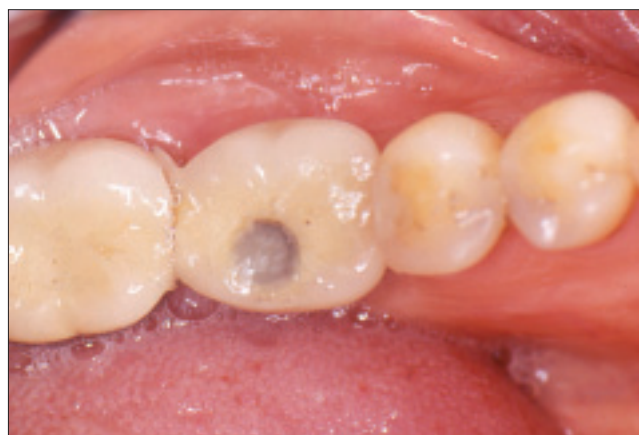
screw had fractured. The patient was advised of the risk of complications that might arise from such a prosthetic design, including damage to the implant and fracture of the solder joint. Approximately 2 months later, the patient returned with the complaint of a fractured restoration. Further evaluation revealed that the solder joint between tooth 37 and the implant at tooth 36 had fractured (**Fig. 5a**).

Figure 5a: Occlusal view of solder joint fracture between tissue-integrated prosthesis and tooth 37.

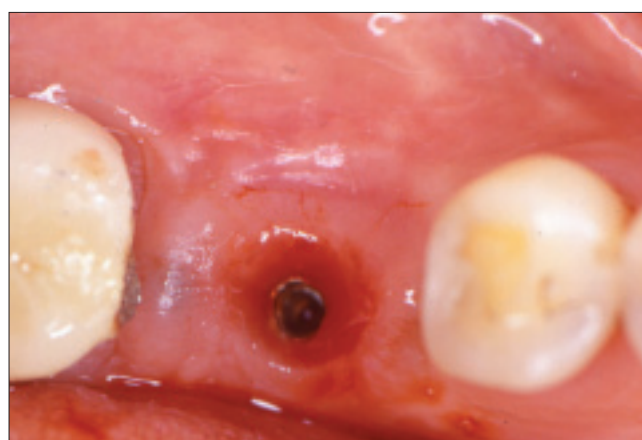
The abutment screw had fractured because of the biomechanical overload on the prosthesis. After removal of the fractured abutment screw (**Fig. 5b**), it was observed that the internal threads of the Brånemark System implant were damaged. In addition, the hexagonal portion of the implant was damaged due to friction caused by the ill-fitting splinted prosthesis (**Fig. 6**). Thus, it would not be possible to use the existing implant for the final restoration.

Figure 5b: Solder joint fracture between tooth 37 and implant at 36 with soft tissue irritation.

Recommendation was made for the placement of 2 new implants to support a ceramo-metal screw-retained restoration replacing the mandibular left first molar, bypassing the

previously placed implant. Consideration was given to trephining out the existing implant; however, significant bone loss and bone damage from heat generation along with paresthesia were of major concern in this patient. Instead, the implant, which was not fractured, was shortened, using copious amounts of saline irrigation, to create more room for the mesial and distal implants while preserving the bone. This was the least invasive form of treatment for this failed implant. Informed consent was obtained from the patient after all options for retreatment were explained.

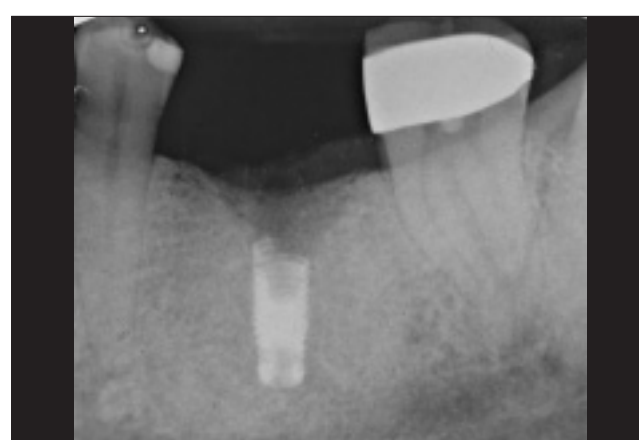
Figure 6: Fractured abutment screw in implant at site 36 with hexagonal portion of implant damaged.
