# The Use of Both Porcelain Veneers and All-Porcelain Crowns in Restoring Anterior Teeth

Omar El-Mowafy, BDS, PhD, FADM

*“Clinical Showcase” is a series of pictorial essays that focus on the technical art of clinical dentistry. The section features step-by-step case demonstrations of clinical problems encountered in dental practice. If you would like to propose a case or recommend a clinician who could contribute to this section, contact editor-in-chief Dr. John O’Keefe at [jokeefe@cda-adc.ca](mailto:jokeefe@cda-adc.ca).*

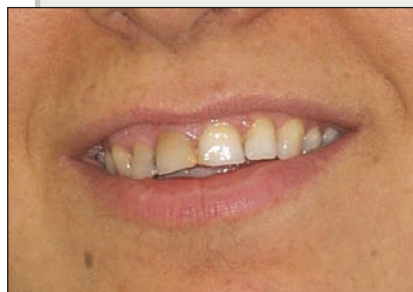
The maxillary anterior teeth of a 39-year-old woman had a less-than-ideal appearance because of discoloration and recurrent carious lesions (**Fig. 1**). Intraoral and radiographic examination revealed that teeth 11, 12 and 13 had undergone endodontic treatment, which was the most likely cause of the discoloration (**Fig. 2**). Although the remaining maxillary teeth had not undergone endodontic treatment, they had become shortened through excessive wear (**Fig. 3**).

**Figure 1:** The patient’s maxillary anterior teeth had incisal wear that resulted in significant reduction in the cervico-incisal length. Teeth 11, 12 and 13 had undergone endodontic treatment and had become discoloured.

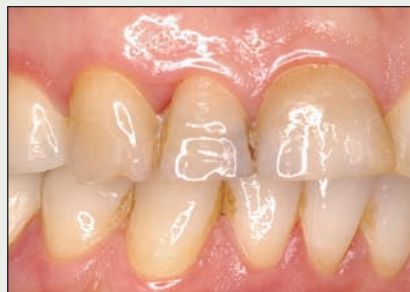
**Figure 2:** Intraoral facial view of teeth 11, 12 and 13 shows evidence of discoloration because of loss of vitality and recurrent caries. There is also evidence of excessive incisal wear.

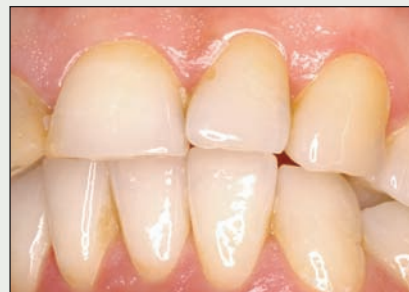
**Figure 3:** Tooth 21 appears too wide because of shortening that occurred with excessive incisal wear.

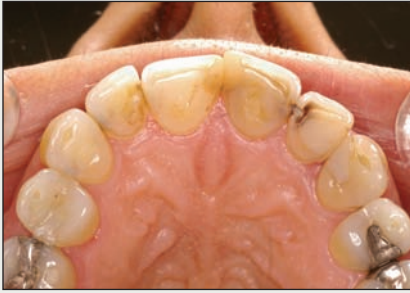
**Figure 4:** Lingual view of the maxillary anterior teeth shows evidence of recurrent caries and incisal wear on teeth 11, 12 and 21 around existing composite restorations. Teeth 22, 23 and 13 had new proximal caries and incisal wear.

21 had recurrent caries around existing composite restorations, whereas teeth 22, 23 and 13 had new proximal caries (Fig. 4). Alginate impressions of the upper and lower arches were obtained, and study models were poured in dental stone. The maxillary anterior teeth on 1 model were waxed up to new anatomic form (Figs. 5a and 5b). A model of the lower teeth was used during this process to verify occlusion and to ensure that incisal lengthening of the teeth was within acceptable limits of the anterior overbite (Fig. 6). The waxed-up model was used for case presentation to the patient. Using a sectional disposable anterior tray, a silicon impression was made of the waxed-up maxillary model (Splash putty, Discus Dental, Culver City, Calif.) (Fig. 7). This was later used for

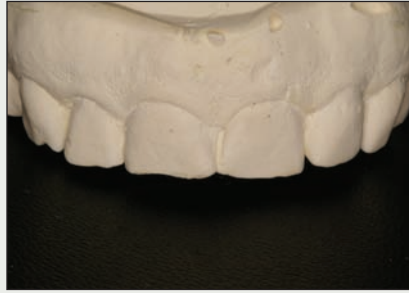
**Figure 5a:** Maxillary diagnostic model.

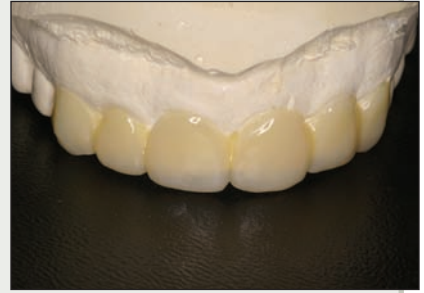
**Figure 5b:** A diagnostic wax-up was made to analyze and determine the shape and size of the restorations. The wax-up was used for case presentation to and discussion with the patient.

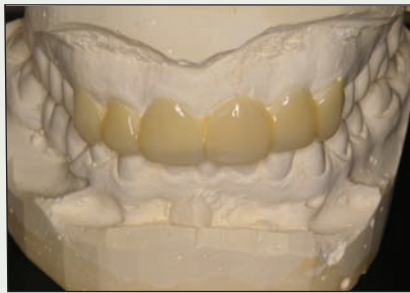
**Figure 6:** A model of the lower teeth was used to verify occlusion and ensure that the degree of overlap of the lengthened maxillary teeth was within acceptable limits.

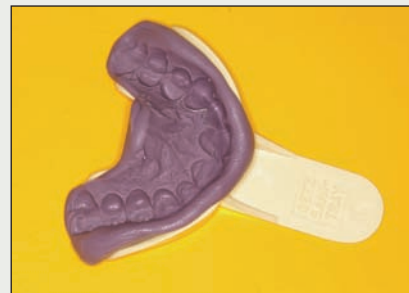
**Figure 7:** A silicon impression of the waxed-up model was made using a sectional disposable anterior tray. This impression was used for fabrication of the provisional crowns and veneers.

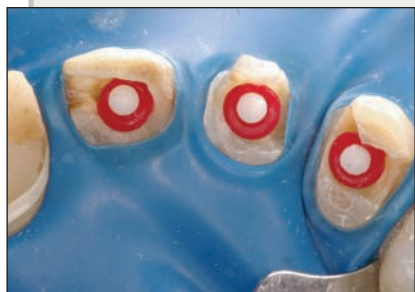
**Figure 9:** Under rubber dam isolation, teeth 11, 12 and 13 were first restored with nonmetallic posts (ParaPost Fiber White 1.25 mm). These posts were supplied with colour-coded O-rings for easy sizing. In this photograph the 3 posts are being tried in after length adjustment.

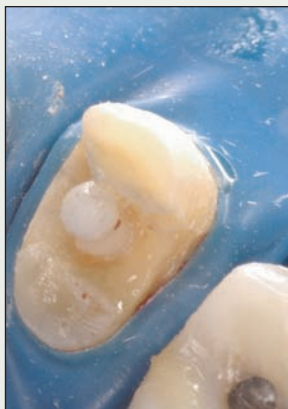
**Figure 10:** Rubber dam isolation was maintained, and the post on tooth 13 was cemented with dual-cure resin cement (Panavia F 2.0).

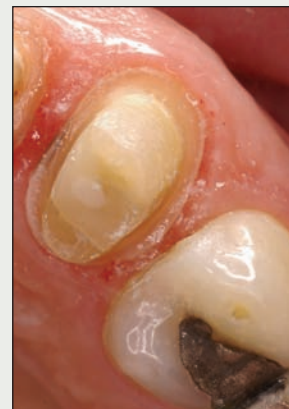
**Figure 11:** A core build-up was created using a composite resin (Z100). The teeth were then prepared to receive the all-porcelain crown restorations.

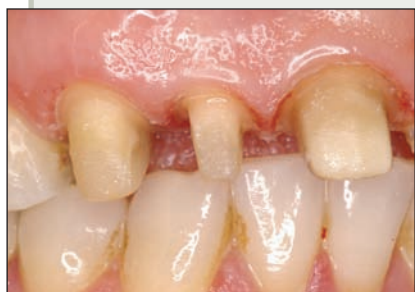
**Figure 12:** Teeth 11, 12 and 13 after restoration with post-and-core buildups and preparation for all-porcelain crown restorations.

were then made using a hybrid composite (Z100, 3M, St. Paul, Minn.) and the same bonding agent. The teeth were then prepared to receive porcelain crowns (Fig. 12) with an all-round shoulder finish line, which is necessary for proper support of the porcelain.

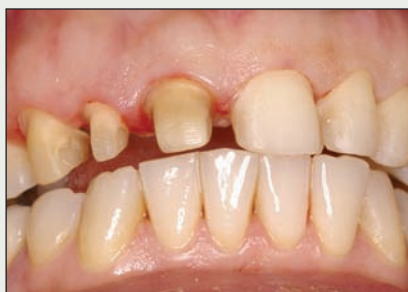
**Figure 13:** Facial view of all prepared teeth. There is clear evidence that the veneer preparations are much more conservative than the porcelain crown preparation. If the restorations of teeth 21, 22 and 23 were to be made in all-porcelain crowns rather than veneers, they would be prepared in a manner similar to the procedure followed for teeth 11, 12 and 13, with much more tooth reduction.

There was clear evidence in the facial view of all prepared teeth (Fig. 13) that the veneer preparations required much less tooth reduction than the all-porcelain crown preparations. A final impression was taken with silicon impression material

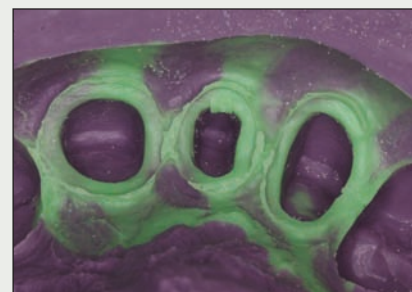
**Figure 14:** An impression was made using silicon impression material (Splash). Note the all-round shoulder finish line, necessary for all-porcelain crowns.

and a putty/wash technique (Splash half-time, Discus Dental) (Fig. 14).

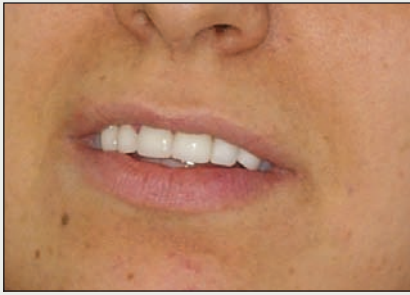
**Figure 15:** Facial view of the patient after provisional restorations were inserted.

Provisional restorations were made using the silicon impression made of the waxed-up model and an injectable provisional restorative material (PerfecTemp II, Discus Dental). These restorations were cemented with a temporary cement (Fig. 15).

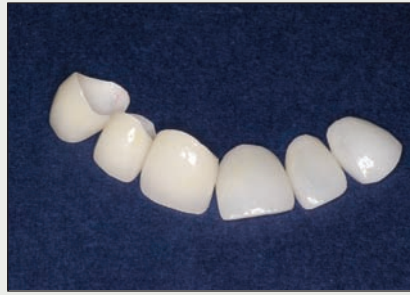
**Figure 16:** Three Procera AllCeram (Nobel Biocare AB) crowns were fabricated for teeth 11, 12 and 13, and 3 IPS-Empress (Ivoclar) porcelain veneers were fabricated for teeth 21, 22 and 23.

Sweden) and 3 IPS-Empress porcelain veneers (Ivoclar, Schaan, Liechtenstien) were fabricated at a commercial dental laboratory (**Fig. 16**). The fit of the restorations was first checked on the model (**Fig. 17**). At the next appointment, the restorations were tried in and cemented with a dual-cure resin cement (Nexus 2, Kerr Corp, Orange, Calif.) and a bonding agent (Prime and Bond NT, Dentsply, Konstanz, Germany) (**Fig. 18**). The 3 crowns were first cemented with the selected shade of the resin cement. The 3 veneers were then tried in with different shades of resin cement until a perfect match to the crowns was achieved. The veneers were then cemented. Each restoration was light-cured with a light-curing unit (IQ Smartlite, Dentsply) for 40 seconds from both facial and lingual aspects. A superior esthetic result was achieved with the 3 nonmetallic crowns on teeth 11, 12 and 13 (**Fig. 19**). **Figure 20** shows the patient after completed treatment. ♦

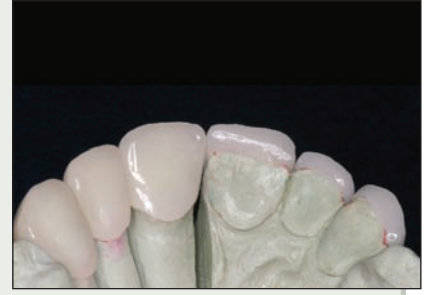
**Figure 17:** The fit of the restorations was checked first on the cast.

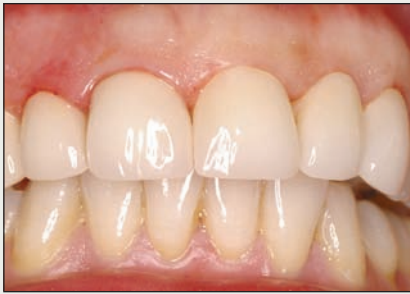
**Figure 18:** Intraoral view immediately after cementation of the restorations. A resin cement (Nexus 2) and a bonding agent (Prime and Bond NT) were used. The selected shade of the resin cement was adjusted to colour-match the veneers to the crowns.

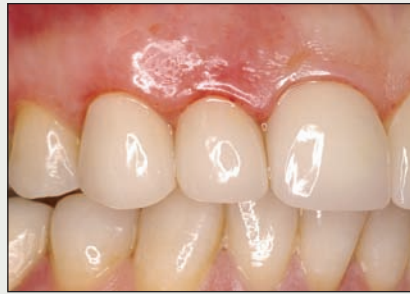
**Figure 19:** Close-up of the 3 Procera AllCeram crowns after cementation. There is excellent colour-matching with the rest of the teeth and superior lifelike esthetics. Initial marginal gingival inflammation in the area of tooth 12 was expected to resolve within 2 weeks.

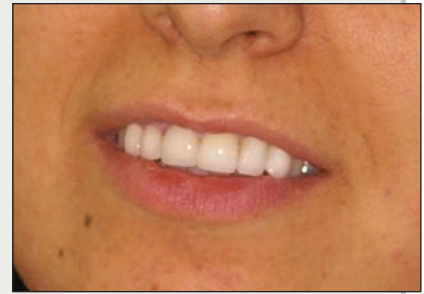
**Figure 20:** Postoperative appearance of the patient. There is good colour match between the veneer and crown restorations.
