# Clinical Showcase

## Get in the Groove

Dr. Tony Pensak, BSc, DDS, FAGD

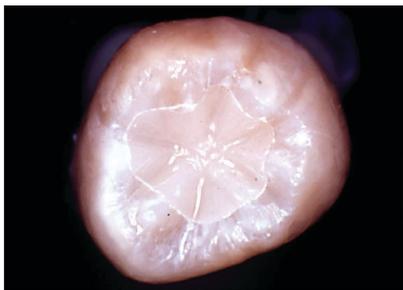
**Figure 1:** Visible white line around polymerized Class I restoration. Photo courtesy of Bisco Dental Products.

Enamel is especially vulnerable to fracturing when tensional stress is high. A white line is often visible either immediately after curing or a few minutes later, once the finishing procedures are completed (Fig. 1). This white line is clearly not a failure at the cavosurface interface, but rather a cohesive fracture within the enamel structure itself (Fig. 2). Although this white line may stain prematurely, in all likelihood it will not lead to premature failure of the entire restoration. On those rare occasions when the white line does not appear, the entire cusp may have sustained a catastrophic fracture that could ultimately cause the tooth to become nonvital.

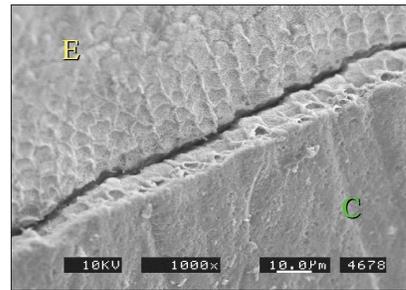
**Figure 2:** Scanning electron microscopy ( $\times 1000$ ) indicates white line is fractured enamel. E = enamel, C = composite. Photo courtesy of Bisco Dental Products.

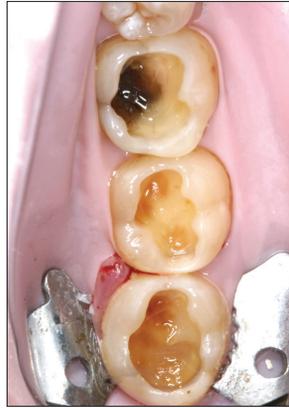
**Figure 4:** Teeth are etched and bonded before placement of self-cure composite (Bisfil II, Bisco Dental Products, Richmond, B.C.).

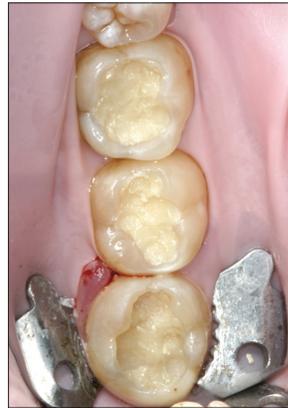
**Figure 5:** Initial increment of Bisfil II surface sealer is placed and chemically cured.

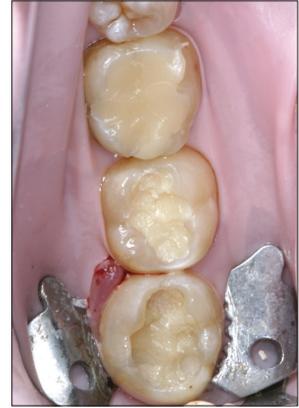
**Figure 6:** An enamel replacement (Microneur, Bisco Dental Products) is placed in the first molar, but not cured.

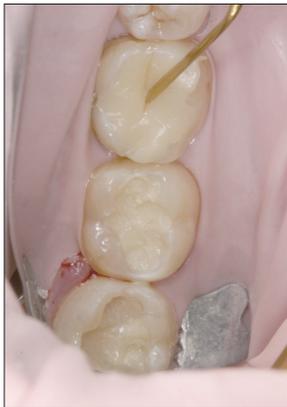
**Figure 7:** Grooves placed in uncured composite. Groove depth should be 1 mm.

With minimal equipment and time, it is possible to significantly reduce this risk and create a more beautiful restoration. The procedure involves simply placing a series of narrow grooves, approximating the developmental grooves, down the middle of the restoration *before* polymerization. This will provide additional unbonded surfaces that can distort during polymerization, thus reducing the stress on the cavosurface margin. A sealer should be applied after polymerization and occlusal adjustment.

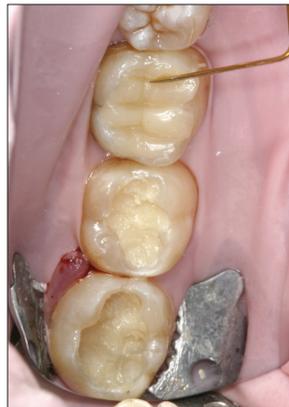
**Figure 8:** Groove placement completed in first molar.

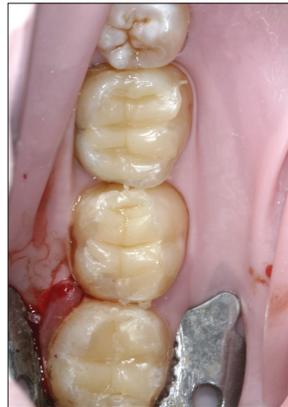
**Figure 9:** Groove placement completed in all 3 molars and cured.

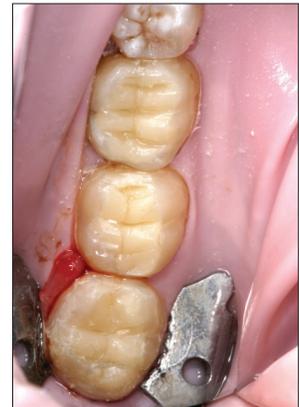
**Figure 10:** Initial marginal detailing completed.

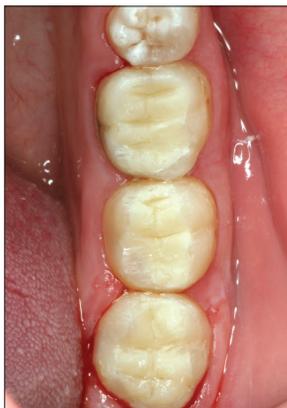
**Figure 11:** Occlusal adjustment completed.

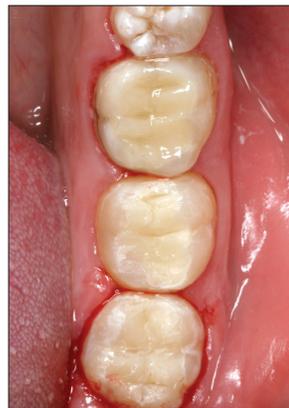
**Figure 12:** At this stage, only the surface of the first molar has been sealed with Biscover (Bisco Dental Products).

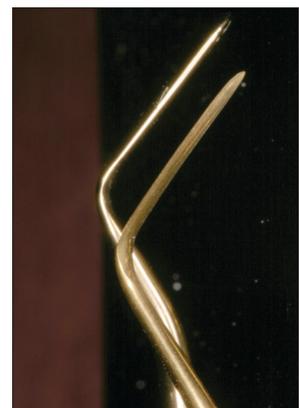
**Figure 14:** Very thin instrument (Interproximal Carver IPC, N-5110P, Bisco Dental Products) used for groove placement (top) compared with instrument of normal thickness.
