Clinical Showcase

Retro Fabrication of a Cast Post and Core to an Existing Crown

Robert David, DDS

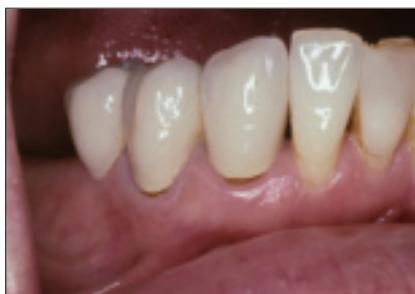
Figure 1: Cantilever bridge with a loose crown on tooth 43. A porcelain fracture is evident on the distal buccal surface of crown 44.

A 50-year-old patient presented with a 3-unit fixed bridge that had been placed by her dentist 4 years before. Full crowns were present on teeth 43 and 44, and a cantilever pontic replaced tooth 45. A hairline fracture was evident in the porcelain on the crown of tooth 44 (Fig. 1). Upon examination, it was noted that the crown on tooth 43 was loose; however, the bridge was comfortable and stable. Endodontic therapy had been performed on tooth 43 before bridge cementation and

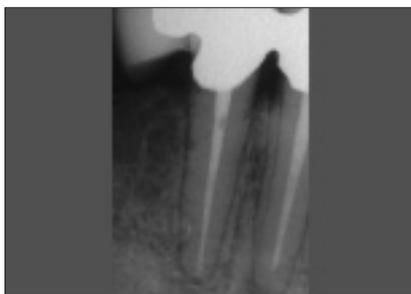
Figure 2: Endodontic therapy was performed on tooth 43 before bridge cementation and on tooth 44 after bridge cementation (through an occlusal access opening). Tooth 43 exhibits an apical radiolucency.

on tooth 44 (through an occlusal opening in the crown) after bridge cementation (Fig. 2).

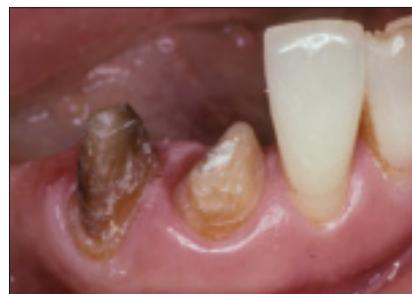
Figure 3: Bridge has been removed.

The bridge was removed using a Higa bridge remover (Higa Manufacturing Limited, West Vancouver, B.C.) (Fig. 3). The coronal two-thirds of tooth 43 had fractured, causing loss of retention and eventual loosening of the crown (Fig. 4). The fractured fragment of tooth 43, which was rigidly attached to the crown, was removed, and the internal aspect of the crown was smoothed. Tooth 43 had a periapical radiolucency and required endodontic retreatment before fabrication of the post (Fig. 5).

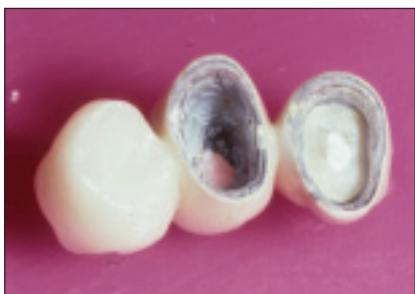
Figure 4: Occlusal half of the abutment tooth 43 is fractured, which has caused the crown to lose its retention and loosen.

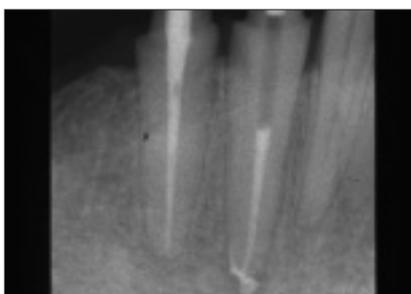
Figure 5: Endodontic retreatment on tooth 43 before fabrication of the post.

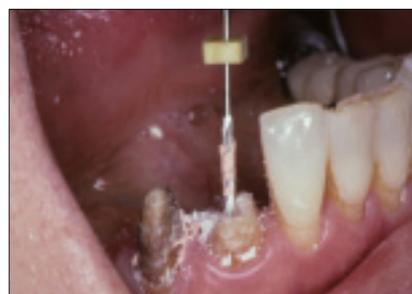
Figure 6: Post space is prepared with a non-end cutting Peeso reamer.

A post space was created by removing the endodontic gutta-percha to within 8 mm from the apex by means of a non-end-cutting Peeso reamer (Endotec Inc, Mani Instruments, Halifax, N.S.) which had been marked with a rubber stopper (Fig. 6). The post space was lubricated with Microfilm (Kerr Manufacturing, Orange, Calif.) applied with a disposable Ultrabrush (Microbrush Corporation, Grafton, Wisc.) (Fig. 7). A powder and liquid brush technique was used to fill the post space with red Duralay self-curing acrylic (Reliance Dental Manufacturing, Worth, Ill.) (Figs. 8a and 8b), and a periodontal probe was used to pump the soft acrylic apically to the base of the post preparation (Fig. 9). A small Spee-Dee preformed acrylic tapered pin (Pulpdent Corporation of America, Watertown, Mass.), wetted with acrylic monomer, was inserted into the apical end of the unset acrylic (Fig. 10). A small acrylic core was then built up around the pin. With the acrylic partially set, yet still flexible, the acrylic post was withdrawn approximately 1–2 mm and then fully resealed several times to prevent it from sticking in the post space. After the acrylic had set completely, the post pattern was removed from the tooth and verified for accuracy (Fig. 11). The acrylic pattern was then replaced into the post space, and the pin and core were reduced (Fig. 12), which made them much smaller than the former tooth preparation; this allowed for complete seating of the bridge. Complete, unimpeded seating of the bridge over the acrylic pattern was verified, and the margins and occlusion were checked for accuracy (Fig. 13).

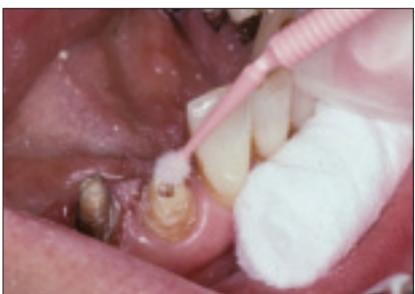
Figure 7: The post space is lubricated with Microfilm.

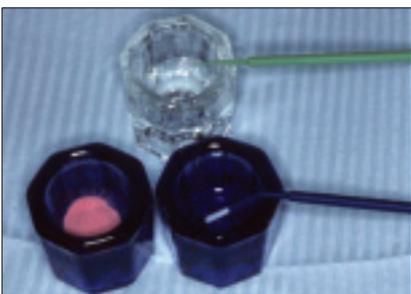
Figure 8a: Red Duralay self-curing acrylic will be used to fill the prepared post space.

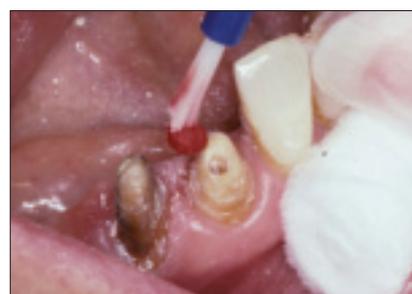
Figure 8b: A powder and liquid brush technique is used to apply the Duralay.

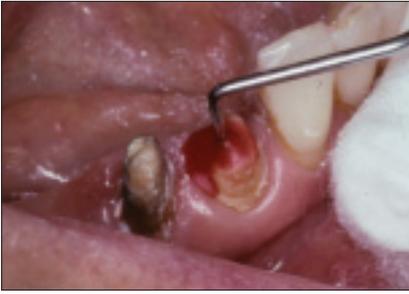
Figure 9: A periodontal probe is used to pump the unset acrylic into the post preparation.

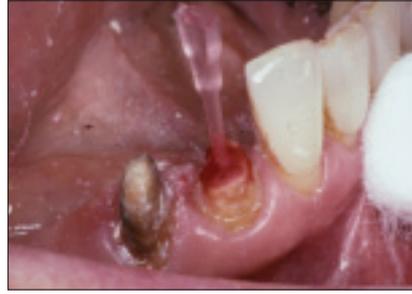
Figure 10: A Spee-Dee acrylic tapered pin wetted with monomer is inserted into the apical end of the post preparation.

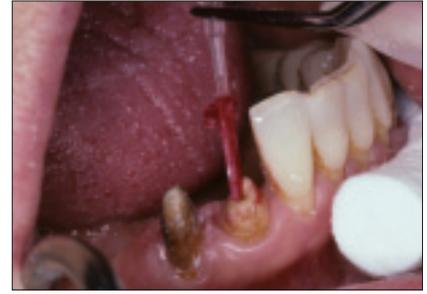
Figure 11: The set acrylic post with a small core is removed from the preparation.

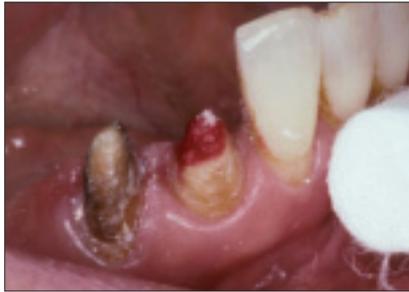
Figure 12: The set acrylic post and core are reduced and adjusted to allow complete seating of the bridge.

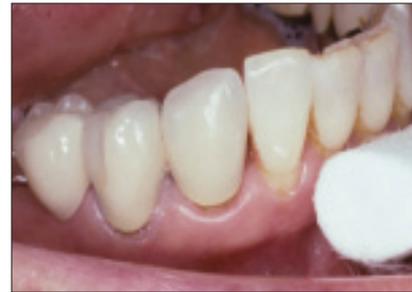
Figure 13: Full seating of the bridge is verified.

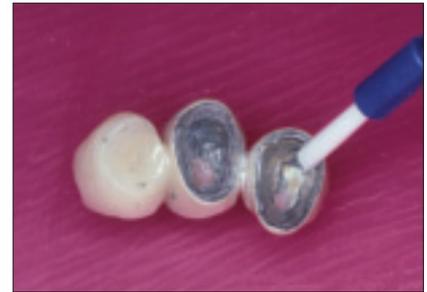
Figure 14a: The crown is lubricated with Microfilm.

The dentin and the undersurface of crown 43 were lightly lubricated with Microfilm (Fig. 14a), and a brush technique was used to fill the crown with Duralay acrylic (Fig. 14b). The bridge, with unset acrylic, was then placed over the teeth with the acrylic post pattern seated in the post preparation. Full seating of the bridge was verified before polymerization. The teeth were held firmly in centric occlusion until the acrylic had set completely (Fig. 15). The bridge, with the set acrylic post and core, was removed from the teeth. The post and core were firmly attached to the undersurface of crown 43 and had to be separated from the crown without damaging the crown or the post (Fig. 16).

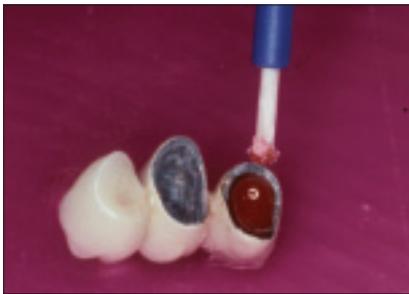
Figure 14b: The crown is then filled with red Duralay acrylic using a powder and liquid brush technique.

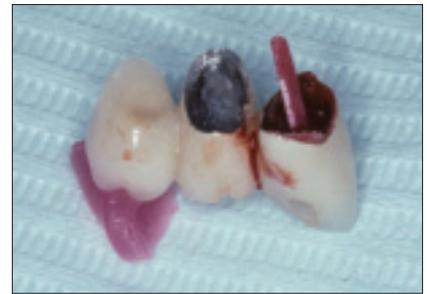
Figure 16: The set acrylic post and core pattern are firmly attached to the crown of tooth 43.

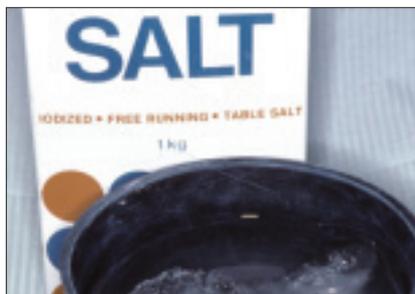
Figure 17: The bridge and attached post and core are placed into a water, ice and salt bath for 20 minutes.

A rubber bowl was filled with cold water and ice cubes, and 2 tablespoons (30 mL) of salt were added to lower the water temperature below the freezing point (Fig. 17). The bridge and the attached post and core were placed into the cold water and left for 20 minutes. The contraction of the acrylic post and core was greater than that of the bridge structure; as a result, the post and core were easily withdrawn from the crown (Fig. 18). The acrylic pattern and the bridge were reverified on the teeth, after which the pattern was sprued to a flat surface of the core and cast in gold. During the laboratory phase of this procedure the bridge was temporarily recemented.

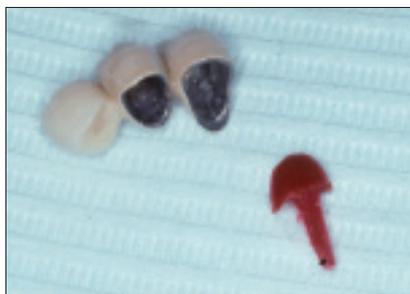
Figure 18: Cooling of the acrylic post and core has caused its shrinkage and easy separation from the crown.

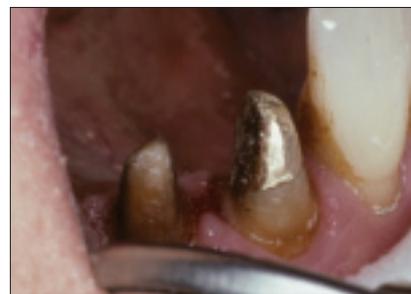
Figure 19: The adjusted gold post and core is gently seated into the tooth and verified.

The cast gold post and core were verified under magnification for irregularities, and excess gold in the sprued area was removed. Most adjustments to an uncemented gold post and core should be made off the tooth, to avoid vibration and heat generation, which could endanger the fragile root. If adjustments are made to the post and core intraorally, copious irrigation should be used to prevent heating and expansion of the gold. Expansion of the precisely fitting gold post could induce micro-fractures in the root. After complete verification and adjustments, the post was placed into the post preparation with gentle finger pressure and verified for complete seating (Fig. 19). The bridge was then inserted and verified.

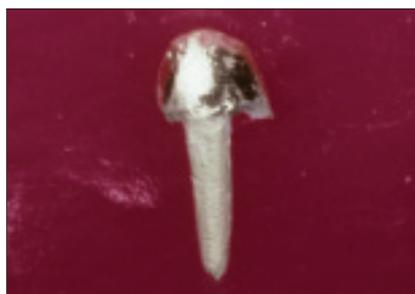
Figure 20: The post is sandblasted and the core is polished.

Before cementation, the post preparation in the root, the post portion of the casting and the undersurface of the crown were sandblasted, and the core portion of the casting was polished (Fig. 20). The post preparation was then irrigated with 0.12% chlorhexidine and dried with paper points. The cast post and core and the bridge were then cemented simultaneously with a glass ionomer cement and verified (Fig. 21). One year after the retro fabrication of the cast post and core, a radiograph indicates that the 5-year-old bridge has regained its retention and resistance and is now stable and functional (Fig. 22).

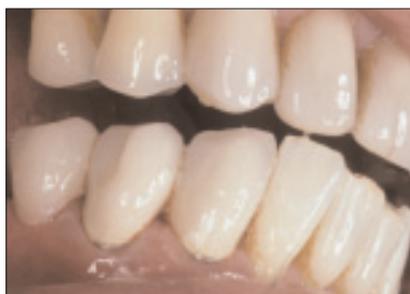
Figure 21: The post and bridge are cemented simultaneously.

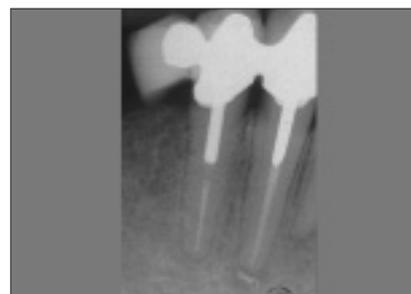
Figure 22: One year after treatment, the radiograph indicates that the retrofitted post and core on tooth 43 provides retention and resistance for the 5-year-old bridge.
