Complete Denture Covering Mandibular Tori Using Three Base Materials: A Case Report

The torus mandibularis presents many challenges when fabricating a complete denture. The mucosa tends to be thin and will not tolerate normal occlusal loads on a denture. Large mandibular tori can prevent complete seating of impression trays and denture. To address this problem, we fabricated a new mandibular complete denture incorporating a combination of soft acrylic flanges and liners.

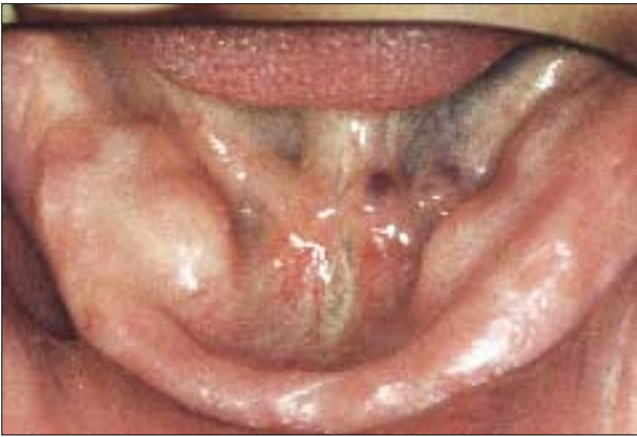
Two bilateral multi-lobulated mandibular tori were present (Fig. 1). The left side was 12.0 mm mesio-distally and 4.0 mm in height. The right side was 20.0 mm mesio-distally and 5.0 mm in height. Both were located just 1.0 mm below the crest of the alveolar ridge. The tori were hard and covered with a very thin layer of mucosa. The patient reported pain whenever a denture was placed on the tori. The previous denture had very little lingual flange in the area of the mandibular tori and was painful to wear at times.

Figure 1: Intraoral view of bilateral mandibular tori.

The existing maxillary denture had an adequate flat plane occlusal scheme and muscle support. Since finances were a concern, we decided to replace the mandibular denture only, incorporating soft acrylic resin flanges and a resilient liner. Standard study casts were made from an alginate impression in very large stock trays. A final alginate impression was made using a border-moulded acrylic custom tray (Fig. 2).

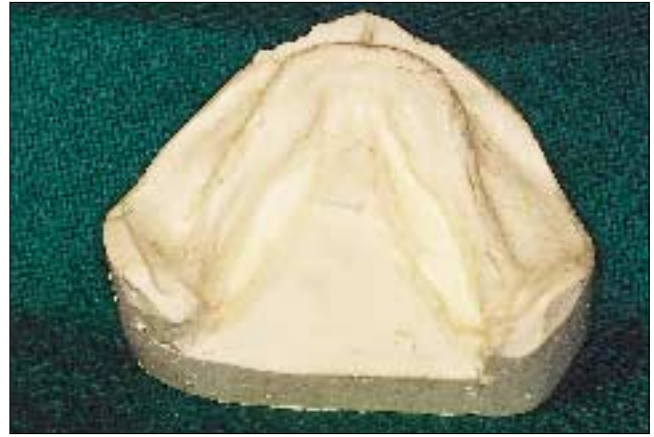
Figure 2: Final model of the mandibular arch.

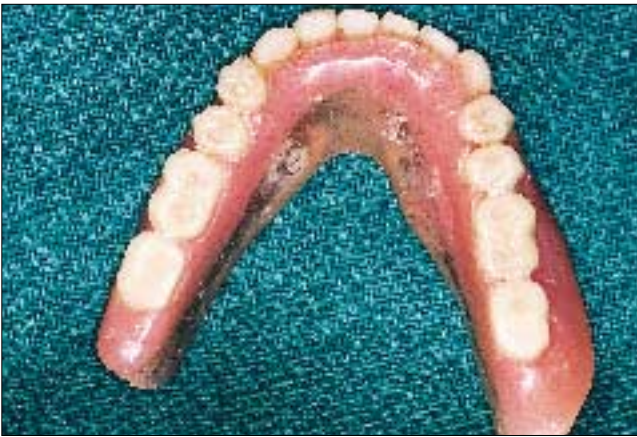
The denture base was constructed with Ivocap (Ivoclar North America, St. Catharines, ON) injected-moulded acrylic resins for the base and buccal flange, a thermoplastic material (BITEM, Thermoplastic Technologies, Newmarket, ON) for the external portion of the lingual flange (Fig. 3) and a resilient material (Molloplast B, Detax GmbH, Ettlingen, Germany) to line the entire denture, including the lingual flange.

Figure 3: Mandibular denture with lingual flange fabricated in BITEM material.

The thermoplastic material BITEM is relatively rigid at mouth temperature but tempers in hot water, softening the material. It is adjusted by first chilling the denture and then polishing or grinding. Essentially, it is a methyl methacrylate, and therefore it bonds chemically to the denture base and the resilient liner. The result is a semi-rigid flange that slides easily over the mandibular tori.

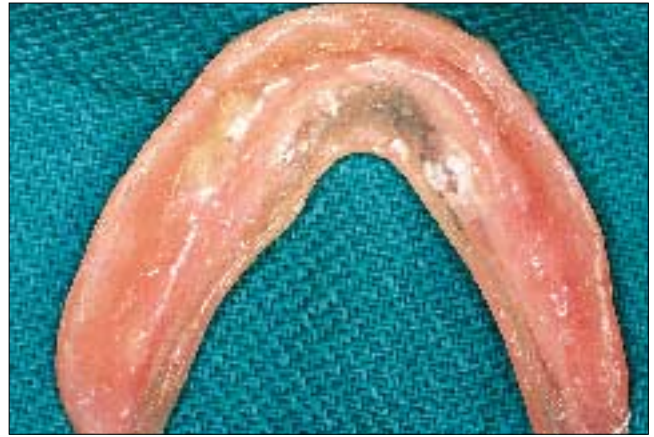
Figure 4: Tissue surface of the mandibular denture.

Initially we had fabricated the lingual flanges in thermoplastic material but found that it locked into the undercut causing denture sores and pain on removal of the denture. The additional placement of a resilient liner solved these problems (Fig. 4).

Our patient found the new denture very retentive without soreness over the mandibular tori. The resilient liner prevented the thermoplastic flanges from locking around the torus and lessened the occlusal load on the torus. The lingual aspect of the denture was slightly thicker than usual due to the position of the torus and the need to stabilize the material. This initially caused some problems with speech, but the patient was able to adapt and has worn the denture for over one year with no need for adjustments in the last 10 months. ♦
